Experimental Investigation of the Track Dynamic Performance for a Downslope Small-Radius Curve in a Metro

X. Liu, H. Jiang, Y. Chen and M. Gao

China Academy of Railway Sciences (Shenzhen) Research and Design Institute Co. Ltd., China Academy of Railway Sciences Corporation Limited
Beijing, China

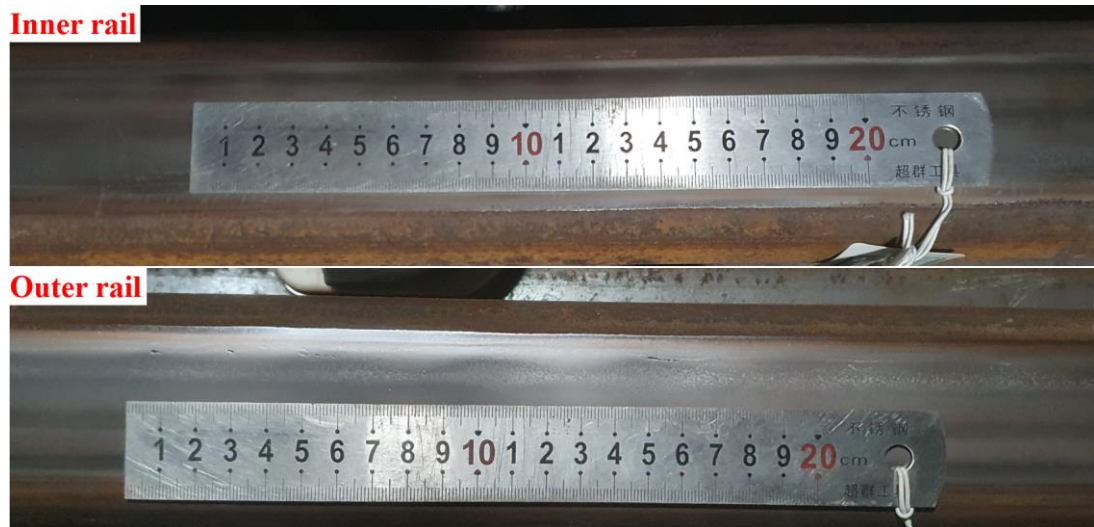
shown in Figure 3. It can be seen that the corrugation on both the inner rail and the outer rail is visible. The difference is that the outer rail has only one dominant wave with a wavelength of around 50 mm. While on the inner rail, the corrugation is more complicated with several different waves from around 20 mm to 50 mm.

Figure 3: Inspection of rail corrugation in the left line.

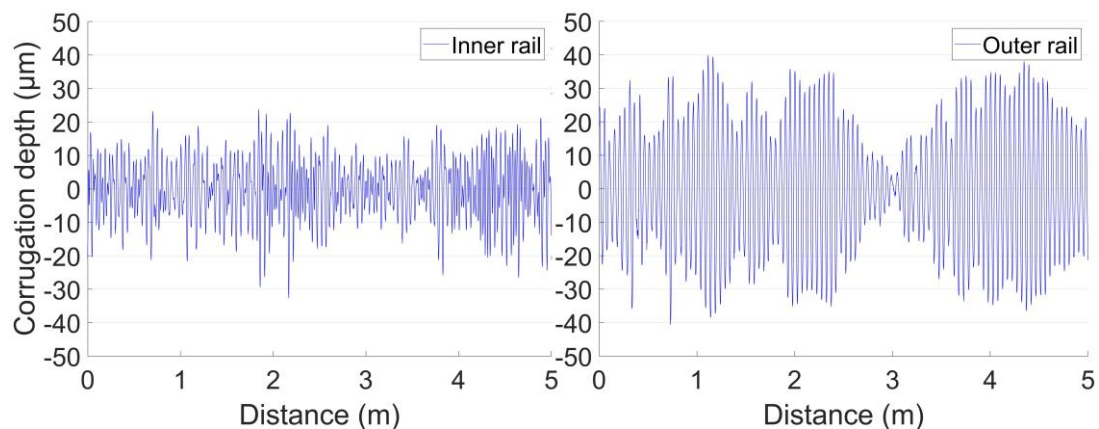
Figure 4: Rail corrugation with the wavelength of 0-100 mm.

It can be seen from Figure 4 that the rail corrugation on the inner rail is shallower and more irregular than that on the outer rail. The maximum depth of the corrugation on the inner rail is around 50 μm , which is around 80 μm on the outer rail.

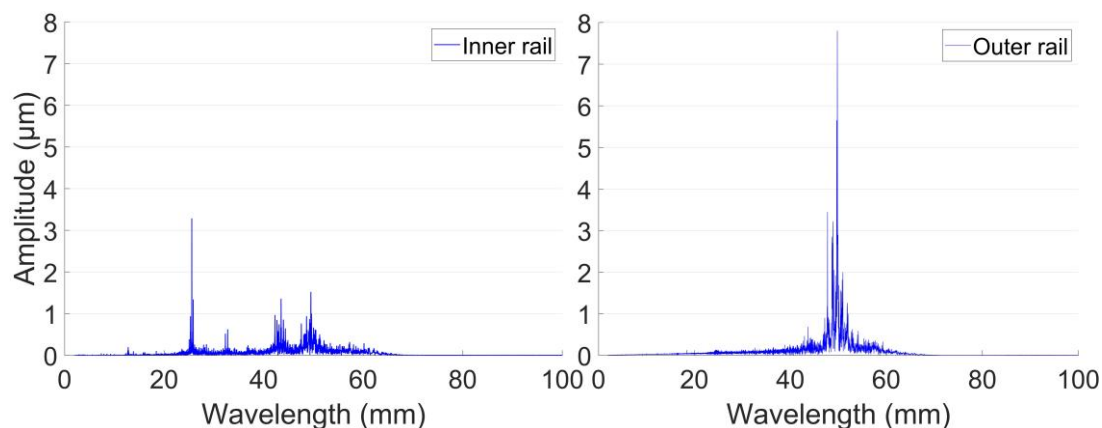
To precisely assess the wavelength of the corrugation, the measurement data are firstly processed using Fourier transform function, and then take the reciprocal of the independent variables. Finally, the distribution curves of corrugation wavelength are obtained, as presented in Figure 5. It is indicated that the inner rail corrugation has four different wavelengths (λ), which are respectively 26 mm, 33 mm, 43 mm and 50 mm.

The train velocity in this section is $v=67$ km/h (18.7 m/s). According to formula (4), the excitation frequencies (f_e) of the inner rail corrugation are 719 Hz, 535 Hz, 435 Hz and 374 Hz, respectively. On the outer rail, there is only one main corrugation wavelength of 50 mm ($f_e=374$ Hz), which is consistent with the longest wave on the inner rail.

Figure 5: Rail corrugation 0-100 mm wavelength distribution curve.

In this line, the rail is 60 kg/m and the sleeper spacing is 0.6 m, so the corresponding typical pinned-pinned frequency is around 1000 Hz^[9]. According to S.L. Grassie^[10], the 43 mm and 50 mm corrugations are likely to be caused by the second torsional resonance of driven axles. For the 26 mm and 33 mm corrugations, the corresponding frequencies are much lower than the pinned-pinned resonance, which might be caused by some unexpected sources. It has to be noted that the train velocity is strictly controlled and downslope overspeed will result in braking deceleration. Since the complex rail corrugations mainly occur in downslope small-radius curves, the wheel-rail contact mechanism needs to be further studied. The influence of rail corrugation is further discussed in combination with the dynamic responses of the track in the next section.

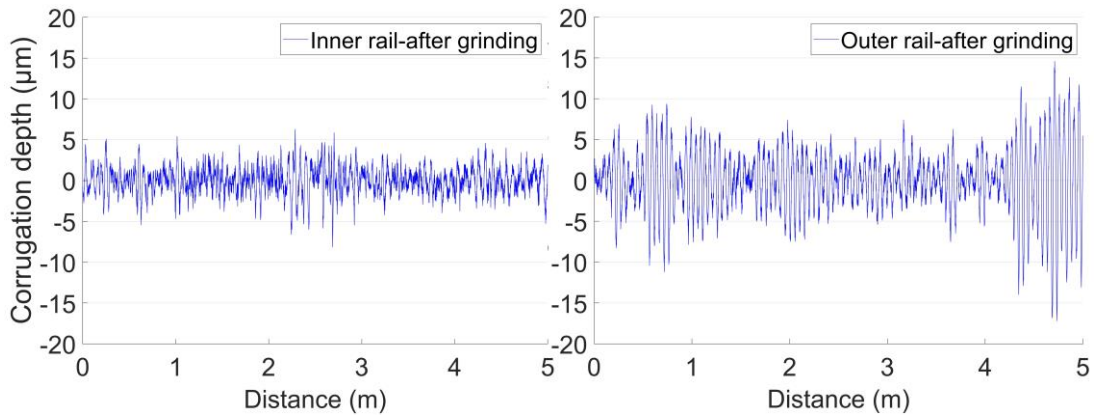
Figure 6: Rail corrugation with the wavelength of 0-100 mm after grinding.

It can be seen that after grinding, the rail corrugations are not eliminated despite no visible marks. The remaining depth of the corrugations on the inner rail and the outer rail are around 10 μm and 30 μm (Figure 6), and the remaining wavelengths on the inner rail and the outer rail are 26 mm and 50 mm (Figure 7), which are respectively the deepest waves in these rails. From this point of view, rail grinding should be performed based on the precise measurement of rail corrugation. The remaining corrugations of this section may still have negative impacts on the dynamic performance of the track.

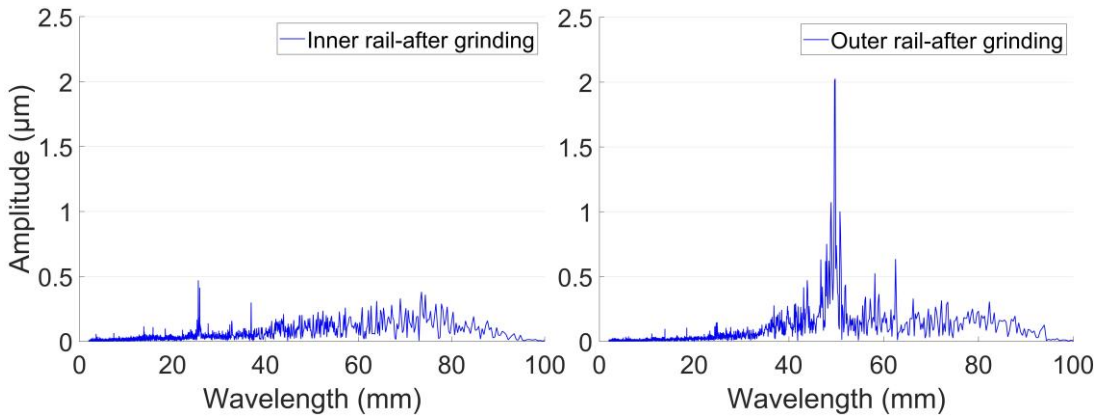
Figure 7: Rail corrugation 0-100 mm wavelength distribution curve after grinding.

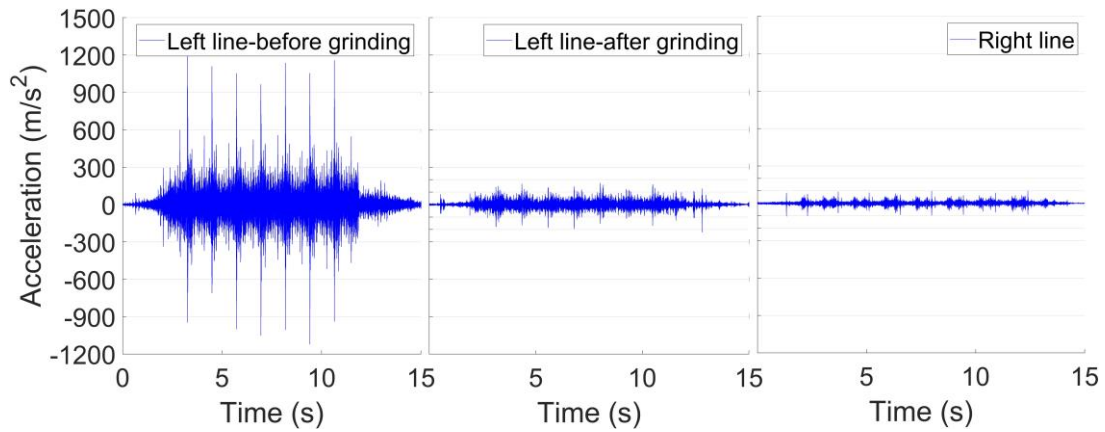
In the field measurements, all the accelerometers are installed on the inner rail side. The rail acceleration responses are given in Figure 8 and Figure 9. It can be seen that for the left line before grinding, the amplitude of rail vertical acceleration is around 1200 m/s^2 , which is significantly higher than that of the right line with no corrugation (around 100 m/s^2). Such results reflect the negative impact of the corrugation on the wheel-rail interaction. After grinding, the rail acceleration level of the left line is reduced to around 200 m/s^2 .

Figure 8: Rail vertical acceleration responses in the time domain in different sections.

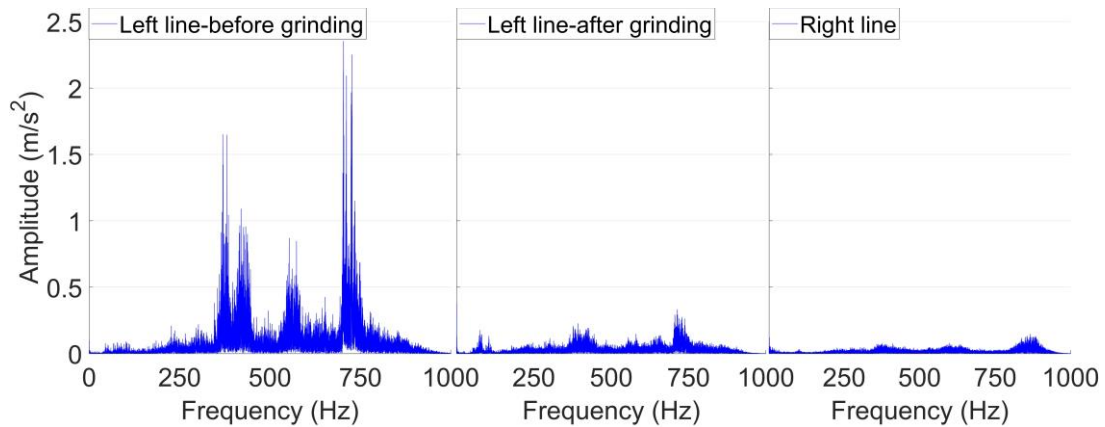
The frequency domain responses of the left line before grinding (Figure 9) clearly show four different major frequencies, e.g. 715 Hz, 560 Hz, 430 Hz and 370 Hz. These frequencies are highly consistent with the corresponding rail corrugations. In this case, the corrugation-induced rail vibration dominated the dynamic responses of the rail.

Figure 9: Rail vertical acceleration responses in the frequency domain in different sections.

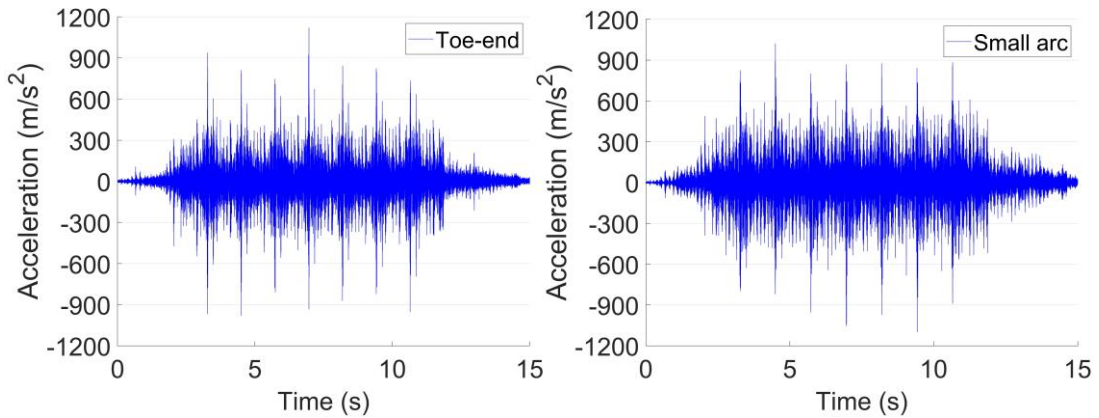
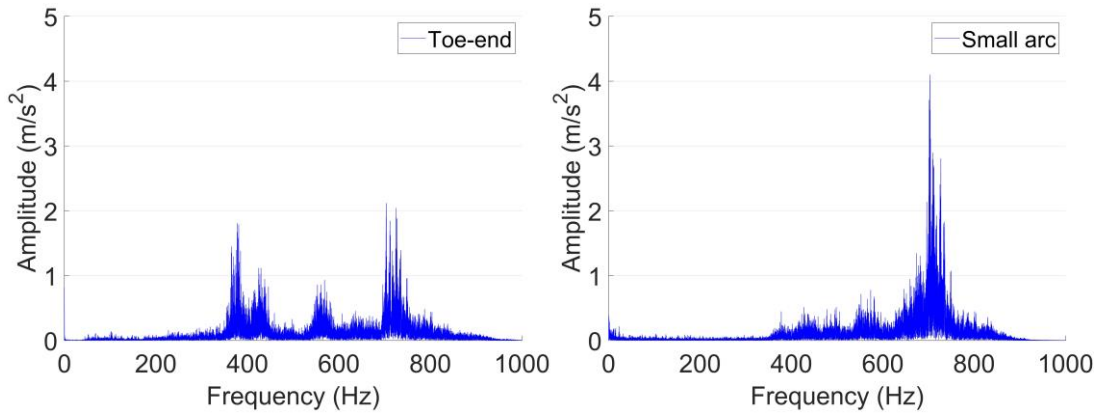
Figure 10: Clip vertical acceleration responses in the time domain in different positions.

Figure 11: Clip vertical acceleration responses in the frequency domain in different positions.

It can be seen from Figure 10 and Figure 11 that in both test points of the clip, the amplitudes of vibration are at the same level as the rail vibration, but the vibration characteristics in the two points are quite different. In the toe-end, the major vibration frequencies are consistent with those of the rail, which is logical with a buckle pressure of around 12 kN. In the small arc, the only dominant frequency is around 720 Hz excited by the corrugation of 26 mm. Since the inherent frequency of this type of clip is 781 Hz and the sensitive frequency range is 707-798 Hz^[11], the corrugation-induced resonance of the clip is likely to be the direct cause of the clip fracture. Considering that the corrugation of 26 mm and clip fracture mainly occurs on the downslope side, the wheel-rail interaction mechanism in such operation conditions needs to be further studied.

2. The excitation frequency of the shortest wavelength (26 mm) on the inner rail is within the clip-sensitive frequency range (707-798 Hz). This corrugation wavelength is likely to be the direct cause of the clip resonance fracture in this section.

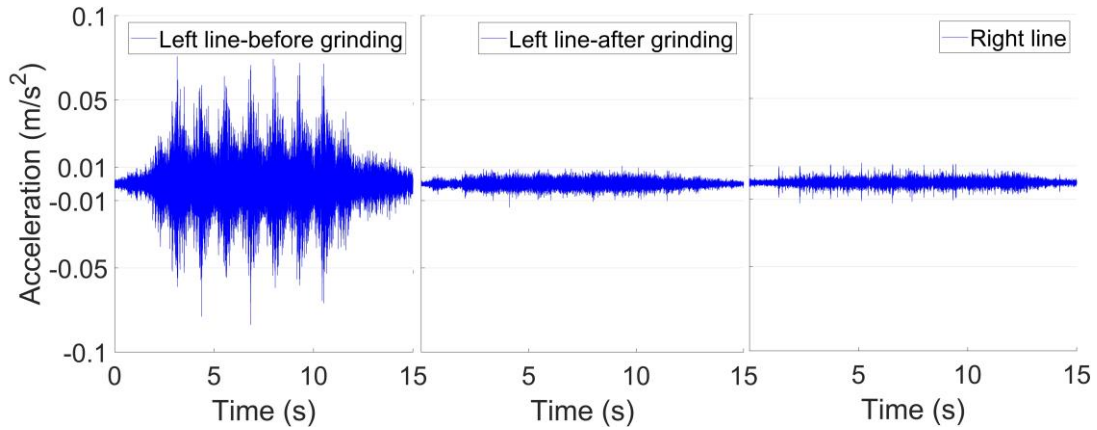
Together with the rail and clip, the vibration of the tunnel wall is also measured and recorded simultaneously, and the measurement results are presented in Figure 12. It can be seen that although the excitation frequencies of the rail corrugation in the left line before grinding are above 300 Hz, which are expected to be filtered out by the steel-spring floating slab, the vibration propagated to the tunnel wall (0.08 m/s^2) remains much higher than that of the right line (0.01 m/s^2). After rail grinding, the tunnel wall vibration of the left line is reduced to the same level as the right line.

Figure 12: Tunnel wall vertical acceleration responses in the time domain in different sections.

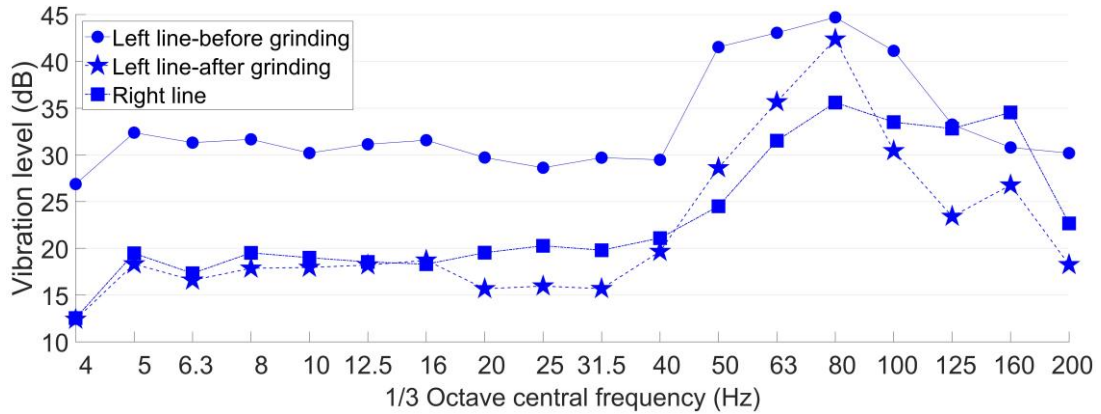
Figure 13: Tunnel wall acceleration responses of different sections in 1/3 Octave spectra.

As presented previously, the vibration level of the tunnel wall in the frequency range of 4-200 Hz is widely used to assess the vibration density of the tunnel lines of urban rail transit, and the key indicator is the maximum vibration acceleration level in 1/3 octave spectra (VL_{max}). The comparison of the tunnel wall acceleration responses of different sections in 1/3 Octave spectra is shown in Figure 13. It can be seen that the corresponding frequency band of VL_{max} is 80 Hz in all the measurement sections. In the left line before rail grinding, the VL_{max} is 45 dB, which is 10 dB higher than that in the right line. In fact, in each band below 100 Hz, the vibration level of the left line before grinding is 10-15 dB higher than that of the right line. After grinding, the vibration level in most of the frequency bands is reduced to the same level as the right line. The adoption of the steel-spring floating slab is to keep the train-induced vibration from transmitting to the environment, while the generation of rail corrugation dramatically reduced such effect.

3. Despite the excitation frequencies being relatively high (374-719 Hz), the vibration propagated to the tunnel wall in the frequency range of 4-200 Hz is also dramatically magnified for more than 10 dB, which largely weakened the vibration control effect of the steel-spring floating slab.
