Experimental Investigation of the Track Dynamic Performance for a Downslope Small-Radius Curve in a Metro

X. Liu, H. Jiang, Y. Chen and M. Gao

China Academy of Railway Sciences (Shenzhen) Research and Design Institute Co. Ltd., China Academy of Railway Sciences Corporation Limited
Beijing, China

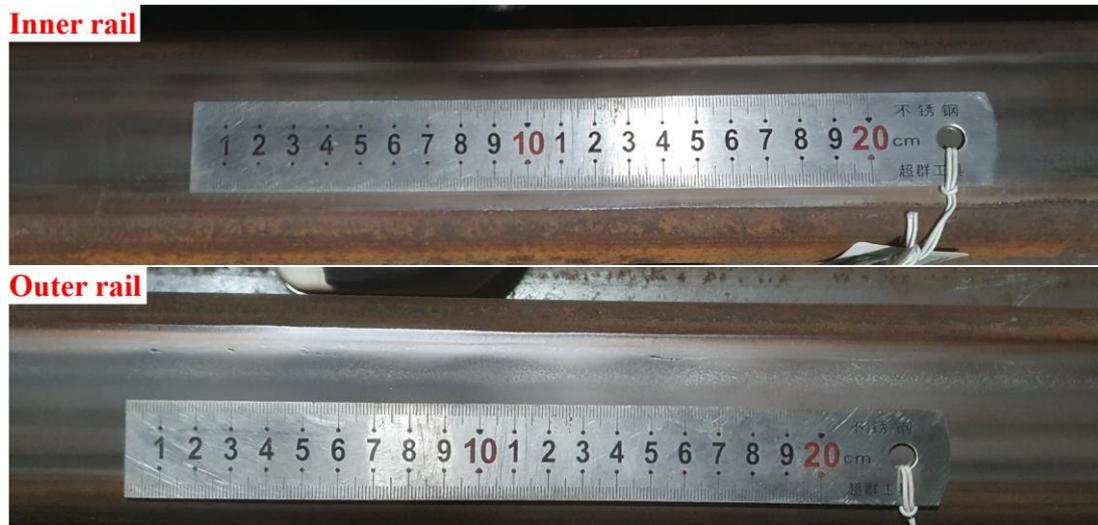
shown in Figure 3. It can be seen that the corrugation on both the inner rail and the outer rail is visible. The difference is that the outer rail has only one dominant wave with a wavelength of around 50 mm. While on the inner rail, the corrugation is more complicated with several different waves from around 20 mm to 50 mm.

Figure 3: Inspection of rail corrugation in the left line.

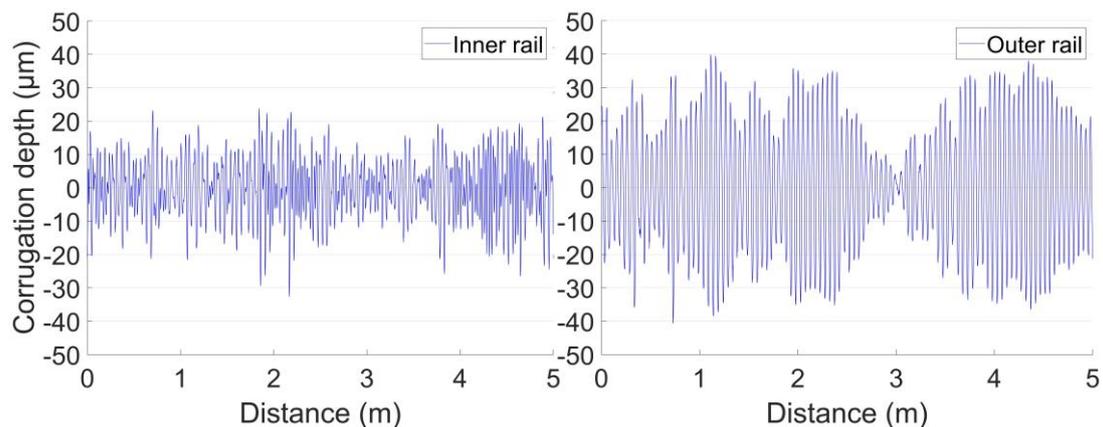
Figure 4: Rail corrugation with the wavelength of 0-100 mm.

It can be seen from Figure 4 that the rail corrugation on the inner rail is shallower and more irregular than that on the outer rail. The maximum depth of the corrugation on the inner rail is around 50 μm , which is around 80 μm on the outer rail.

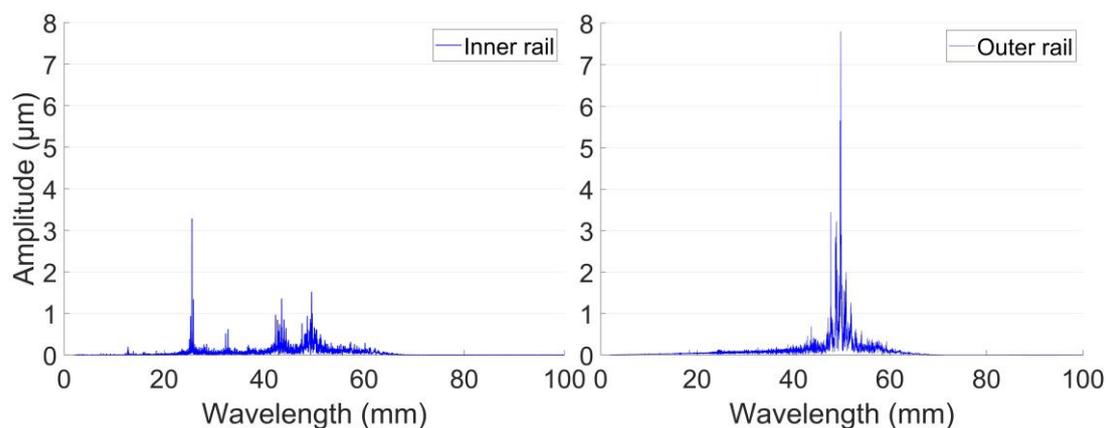
To precisely assess the wavelength of the corrugation, the measurement data are firstly processed using Fourier transform function, and then take the reciprocal of the independent variables. Finally, the distribution curves of corrugation wavelength are obtained, as presented in Figure 5. It is indicated that the inner rail corrugation has four different wavelengths (λ), which are respectively 26 mm, 33 mm, 43 mm and 50 mm.

The train velocity in this section is $v=67$ km/h (18.7 m/s). According to formula (4), the excitation frequencies (f_e) of the inner rail corrugation are 719 Hz, 535 Hz, 435 Hz and 374 Hz, respectively. On the outer rail, there is only one main corrugation wavelength of 50 mm ($f_e=374$ Hz), which is consistent with the longest wave on the inner rail.

Figure 5: Rail corrugation 0-100 mm wavelength distribution curve.

In this line, the rail is 60 kg/m and the sleeper spacing is 0.6 m, so the corresponding typical pinned-pinned frequency is around 1000 Hz^[9]. According to S.L. Grassie^[10], the 43 mm and 50 mm corrugations are likely to be caused by the second torsional resonance of driven axles. For the 26 mm and 33 mm corrugations, the corresponding frequencies are much lower than the pinned-pinned resonance, which might be caused by some unexpected sources. It has to be noted that the train velocity is strictly controlled and downslope overspeed will result in braking deceleration. Since the complex rail corrugations mainly occur in downslope small-radius curves, the wheel-rail contact mechanism needs to be further studied. The influence of rail corrugation is further discussed in combination with the dynamic responses of the track in the next section.

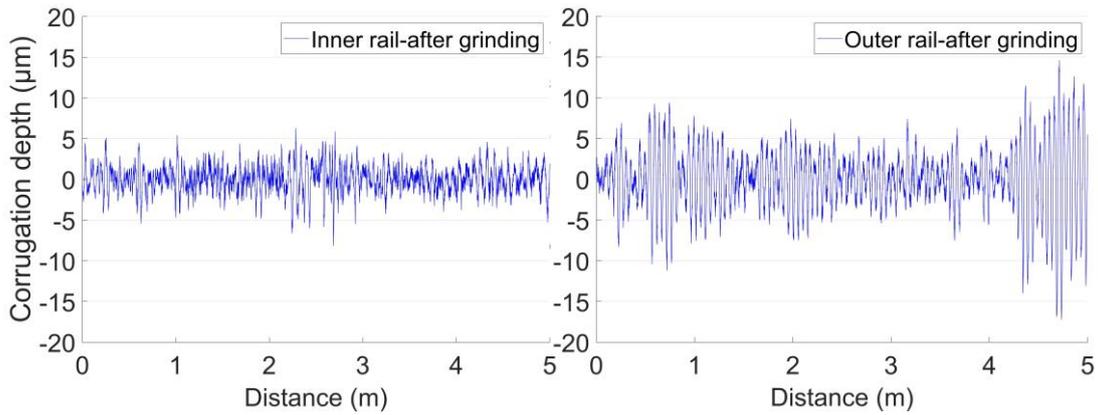
Figure 6: Rail corrugation with the wavelength of 0-100 mm after grinding.

It can be seen that after grinding, the rail corrugations are not eliminated despite no visible marks. The remaining depth of the corrugations on the inner rail and the outer rail are around 10 μm and 30 μm (Figure 6), and the remaining wavelengths on the inner rail and the outer rail are 26 mm and 50 mm (Figure 7), which are respectively the deepest waves in these rails. From this point of view, rail grinding should be performed based on the precise measurement of rail corrugation. The remaining corrugations of this section may still have negative impacts on the dynamic performance of the track.

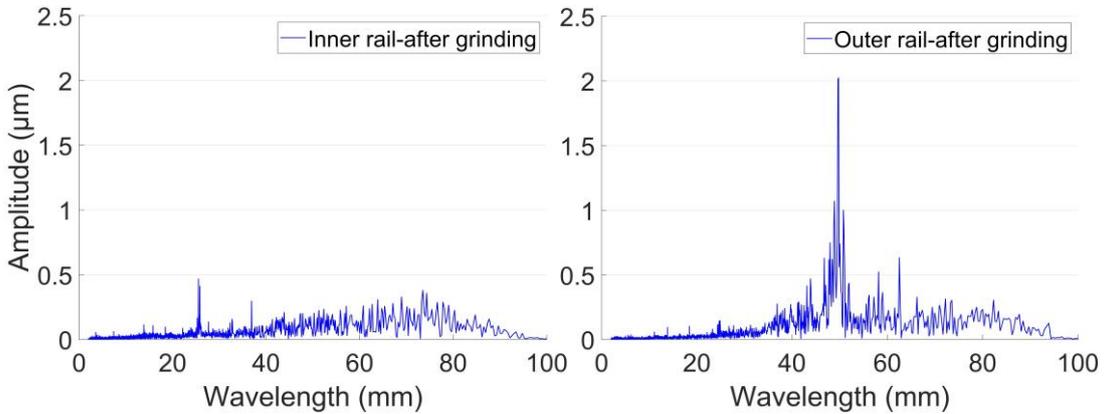
Figure 7: Rail corrugation 0-100 mm wavelength distribution curve after grinding.

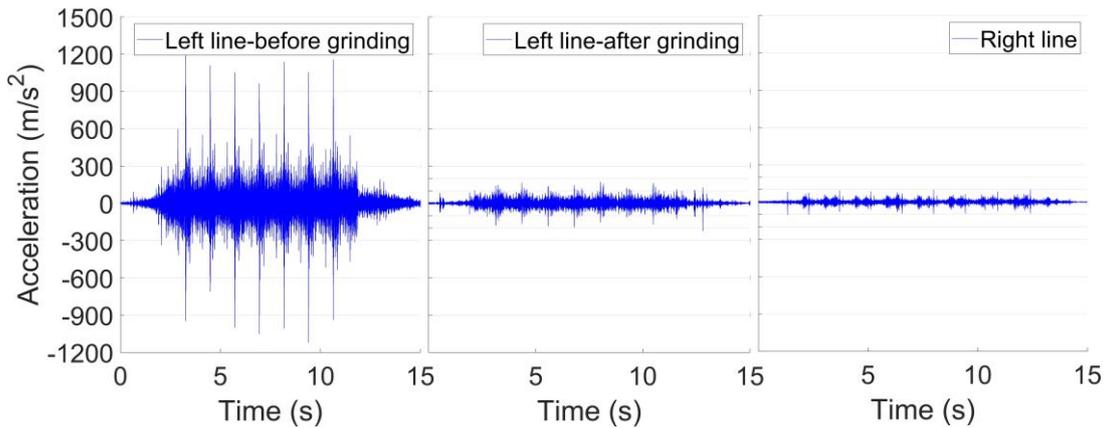
In the field measurements, all the accelerometers are installed on the inner rail side. The rail acceleration responses are given in Figure 8 and Figure 9. It can be seen that for the left line before grinding, the amplitude of rail vertical acceleration is around 1200 m/s^2 , which is significantly higher than that of the right line with no corrugation (around 100 m/s^2). Such results reflect the negative impact of the corrugation on the wheel-rail interaction. After grinding, the rail acceleration level of the left line is reduced to around 200 m/s^2 .

Figure 8: Rail vertical acceleration responses in the time domain in different sections.

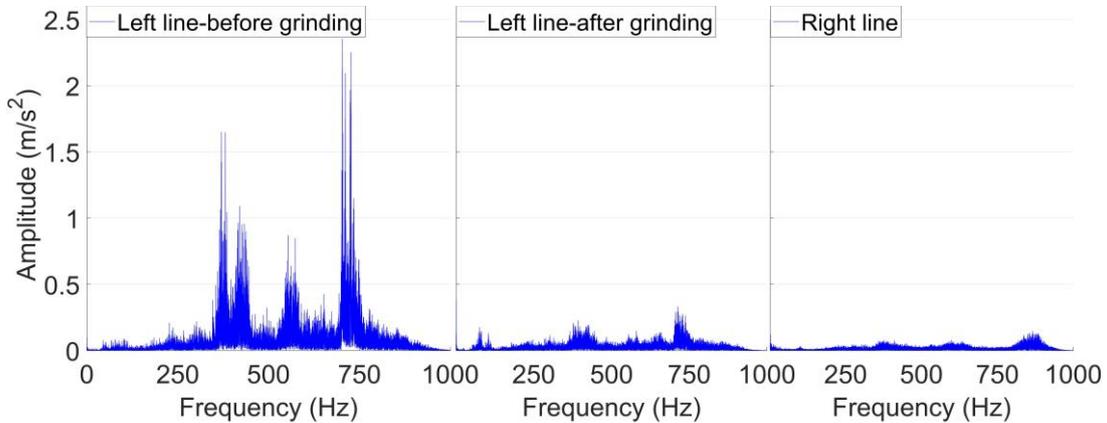
The frequency domain responses of the left line before grinding (Figure 9) clearly show four different major frequencies, e.g. 715 Hz, 560 Hz, 430 Hz and 370 Hz. These frequencies are highly consistent with the corresponding rail corrugations. In this case, the corrugation-induced rail vibration dominated the dynamic responses of the rail.

Figure 9: Rail vertical acceleration responses in the frequency domain in different sections.

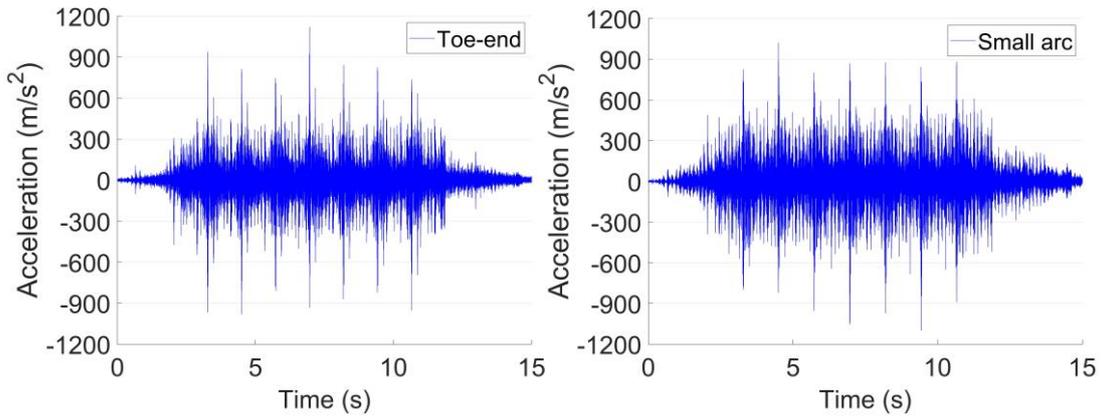
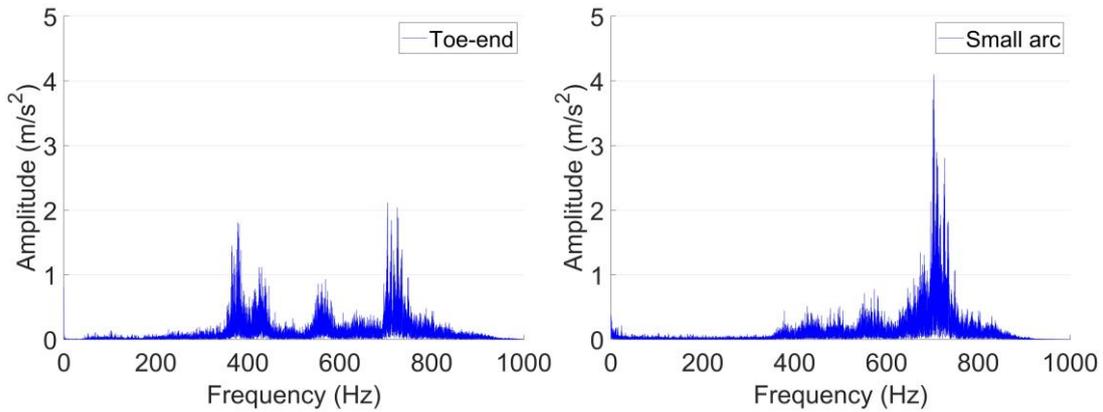
The negative impact of the rail corrugation is quite serious. Sudden fracture of clips has been frequently reported in this section. The fracture point is mainly in the small arc (Figure 2). In this study, the vibrations of a clip (near the rail vibration test point) in both the toe-end and the small arc are measured. The clip measurement results of the left line before grinding are presented in Figure 10 and Figure 11.

Figure 10: Clip vertical acceleration responses in the time domain in different positions.

Figure 11: Clip vertical acceleration responses in the frequency domain in different positions.

It can be seen from Figure 10 and Figure 11 that in both test points of the clip, the amplitudes of vibration are at the same level as the rail vibration, but the vibration characteristics in the two points are quite different. In the toe-end, the major vibration frequencies are consistent with those of the rail, which is logical with a buckle pressure of around 12 kN. In the small arc, the only dominant frequency is around 720 Hz excited by the corrugation of 26 mm. Since the inherent frequency of this type of clip is 781 Hz and the sensitive frequency range is 707-798 Hz^[11], the corrugation-induced resonance of the clip is likely to be the direct cause of the clip fracture. Considering that the corrugation of 26 mm and clip fracture mainly occurs on the downslope side, the wheel-rail interaction mechanism in such operation conditions needs to be further studied.

2. The excitation frequency of the shortest wavelength (26 mm) on the inner rail is within the clip-sensitive frequency range (707-798 Hz). This corrugation wavelength is likely to be the direct cause of the clip resonance fracture in this section.

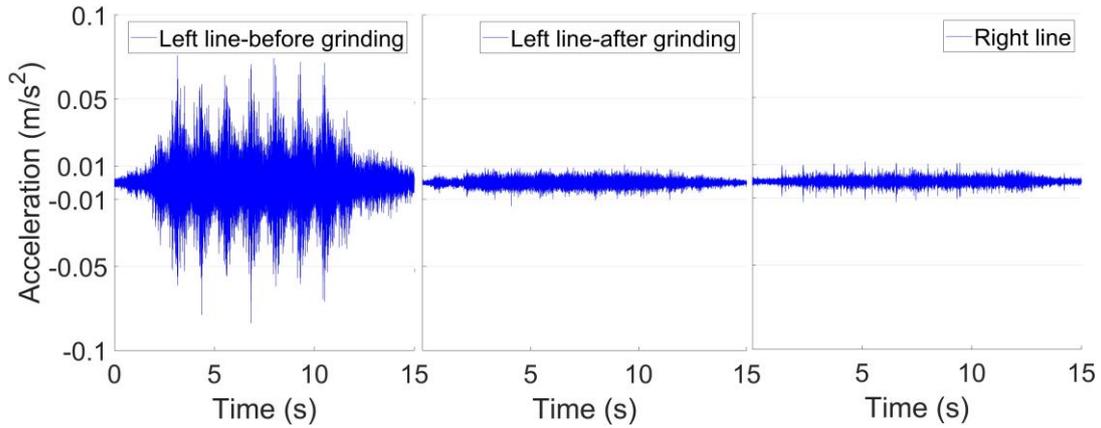
Together with the rail and clip, the vibration of the tunnel wall is also measured and recorded simultaneously, and the measurement results are presented in Figure 12. It can be seen that although the excitation frequencies of the rail corrugation in the left line before grinding are above 300 Hz, which are expected to be filtered out by the steel-spring floating slab, the vibration propagated to the tunnel wall (0.08 m/s^2) remains much higher than that of the right line (0.01 m/s^2). After rail grinding, the tunnel wall vibration of the left line is reduced to the same level as the right line.

Figure 12: Tunnel wall vertical acceleration responses in the time domain in different sections.

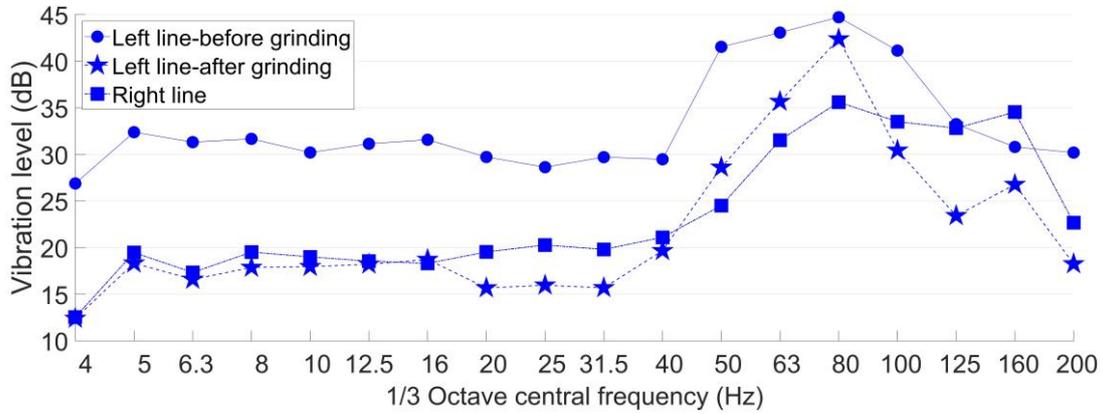
Figure 13: Tunnel wall acceleration responses of different sections in 1/3 Octave spectra.

As presented previously, the vibration level of the tunnel wall in the frequency range of 4-200 Hz is widely used to assess the vibration density of the tunnel lines of urban rail transit, and the key indicator is the maximum vibration acceleration level in 1/3 octave spectra (VL_{max}). The comparison of the tunnel wall acceleration responses of different sections in 1/3 Octave spectra is shown in Figure 13. It can be seen that the corresponding frequency band of VL_{max} is 80 Hz in all the measurement sections. In the left line before rail grinding, the VL_{max} is 45 dB, which is 10 dB higher than that in the right line. In fact, in each band below 100 Hz, the vibration level of the left line before grinding is 10-15 dB higher than that of the right line. After grinding, the vibration level in most of the frequency bands is reduced to the same level as the right line. The adoption of the steel-spring floating slab is to keep the train-induced vibration from transmitting to the environment, while the generation of rail corrugation dramatically reduced such effect.

3. Despite the excitation frequencies being relatively high (374-719 Hz), the vibration propagated to the tunnel wall in the frequency range of 4-200 Hz is also dramatically magnified for more than 10 dB, which largely weakened the vibration control effect of the steel-spring floating slab.
