Spalling defect of head-hardened rail in railway turnouts

M. Messaadi¹, M. Steenbergen² and I. Shevtsov³

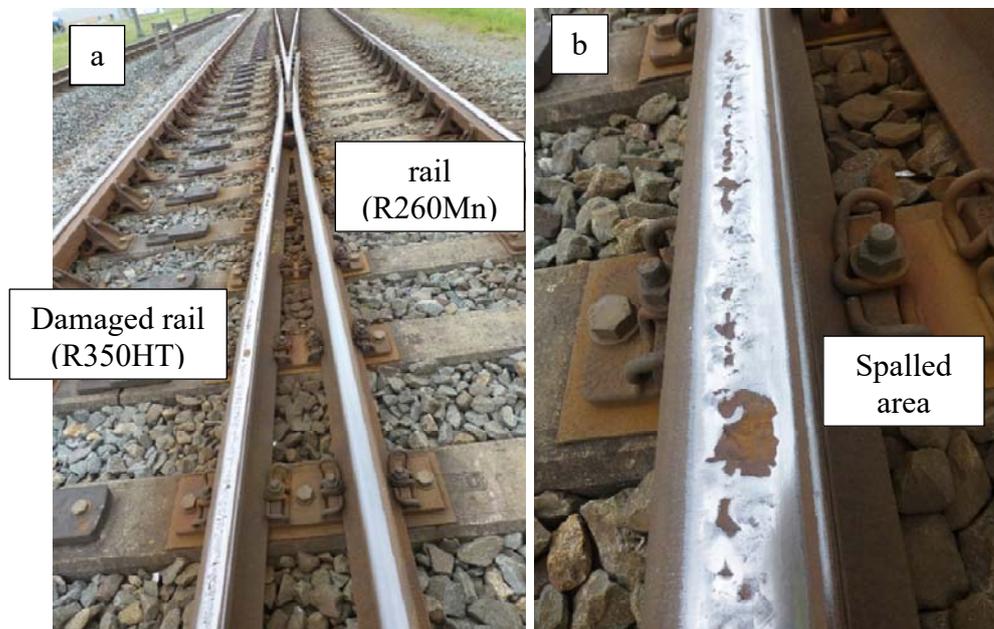
Figure 1. Switch defects observed in the Dutch network; a-overview of the switch, b- Spalling defects on the switch running rail.

is almost no published literature on this subject. Additionally, the field inspections showed that the damage was spread into the head-hardened grade rather than the standard. Figure 1-a presents an overview of an investigated switch. It confirms the difference in damage processes in rail grades. In the same track location, the head-hardened rail exhibits a harmful running band compared to the neighbor rail made from a standard grade. Figure 1-b details the spalling aspects. It shows various and discontinuous spalled areas coexisting with an extensively deformed surface.

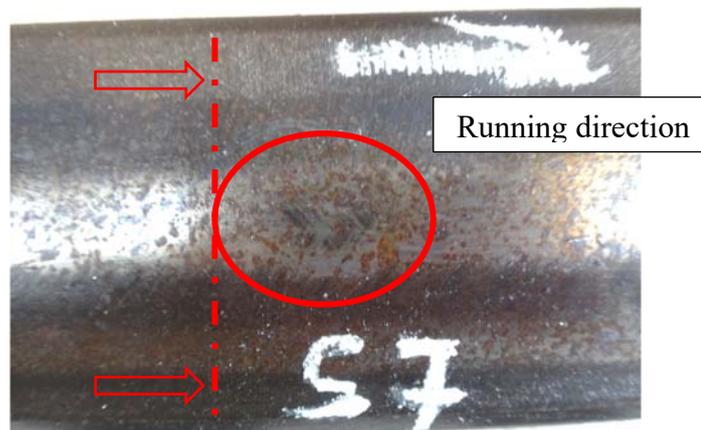
Figure 2. The appearance of the early-stage defect.

This paper presents the results of exclusively one damage type named an ‘early-stage spalling defect’. Figure 2 presents his appearance where the only groovy surface is marked in the middle of the running band. Obviously, it is a distinct feature compared to rolling contact fatigue failing forms described elsewhere [8]. This suggests also that the defect development scenario may differ.

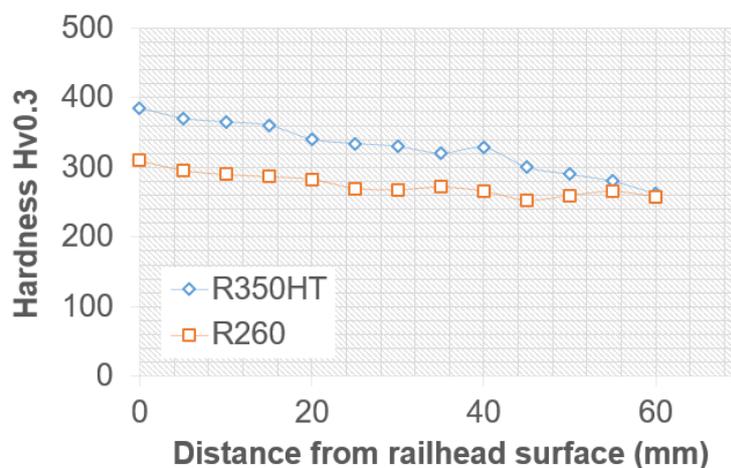
Figure 3. Hardness profile measured in the transversal direction of rail heads: R260 standard grade and the R350HT from [10].

Figure 3 illustrates the hardness profiles along the railhead of the two grades. Obviously, the head-hardened grade has a higher hardness that is decreasing until reaching a comparable value to the standard grade. This difference in hardness distribution affects the ratcheting and the damaging behavior of steels. The author thinks that still a crucial point not well discussed in the literature concerning the clearness of these grades. In another word, the amount of non-metallic inclusions, oxides, and voids present in the microstructure.

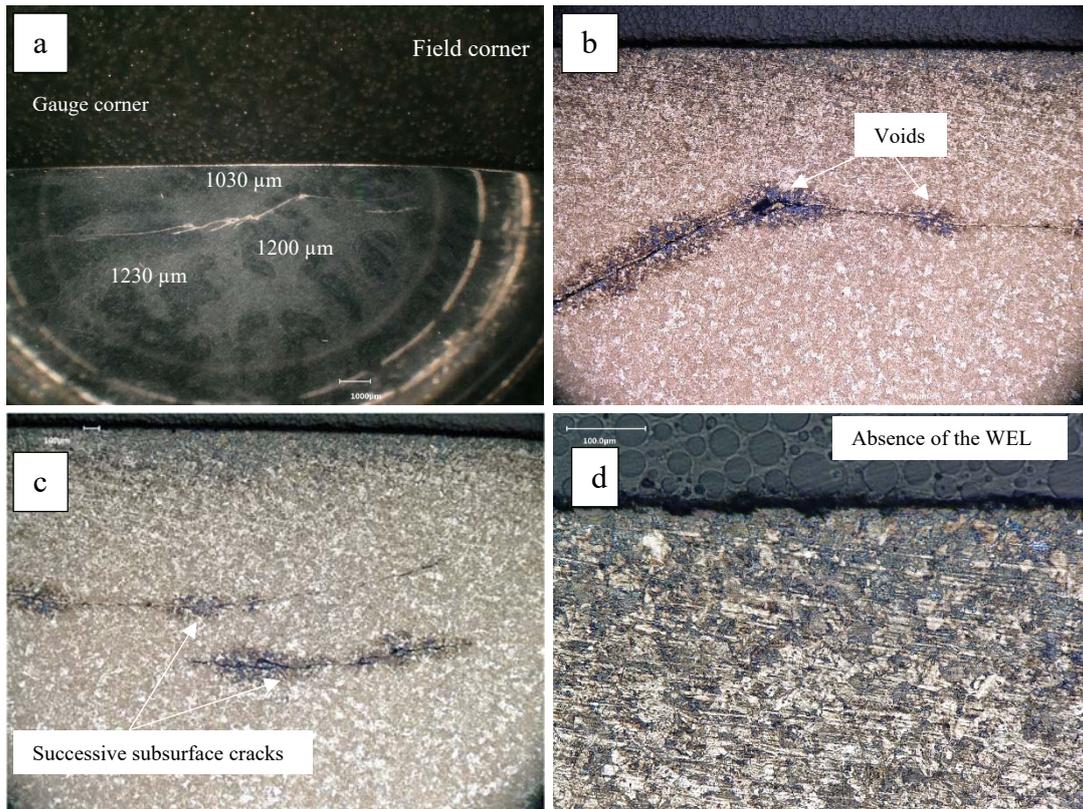
The metallographic expertise of the spalling defect revealed the presence of subsurface cracks. Figure 4-a presents an overview of the transversal cross-section showing the wings crack type. It shows bidirectional cracks initiated from subsurface voids at around 1 mm underneath the surface. In the gauge corner side, cracks grow into the material generating successive cracks clusters (see Figure 4-b). Meanwhile, on the field corner side, the subsurface cracks seem to be unconnected and appear parallel with different lengths as illustrated in Figure 4-c.

Regarding the literature, a comparable crack feature was reported by Grassiel et al. in the case of stud defect however no clusters were reported [12]. Besides, a crucial difference in comparison to the stud defect is the absence of the white etching layers and the plastic deformation above the wings crack. The metallographic investigation shows no white etching layer and no accumulated plastic flow in Figure 4-d.

Figure 4. Optical microscopy observations of the early-stage defect cross-section.

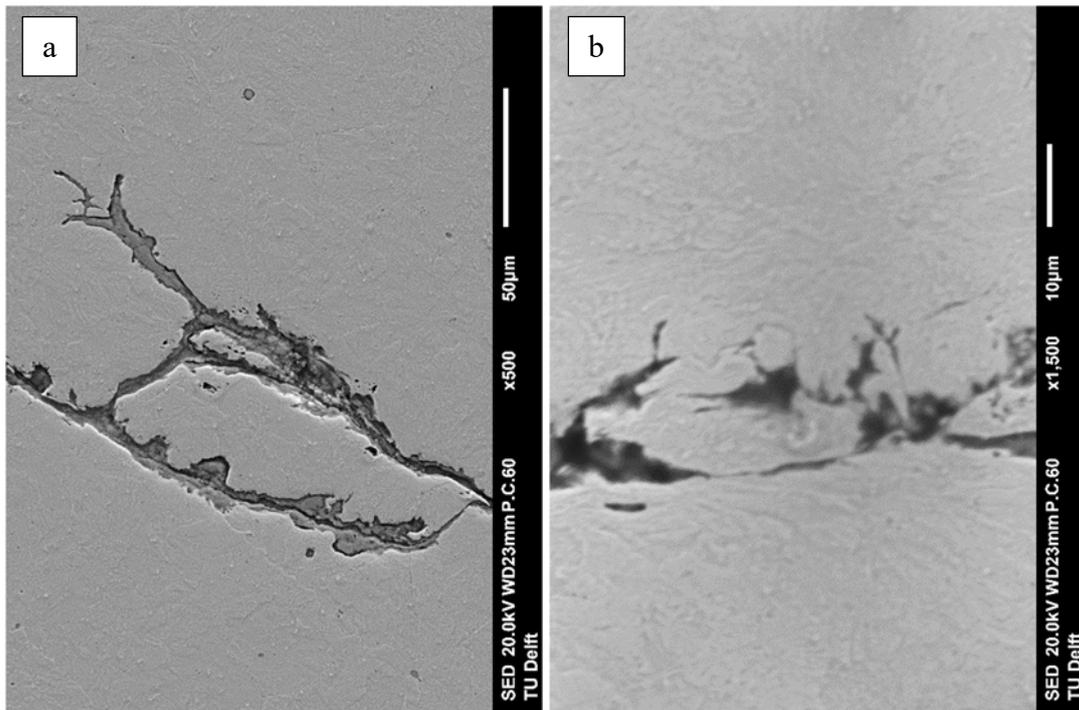
Figure 5 depicts two illustrative images; figure 5-a presents an example of a cracks cluster showing the clear repetitive bifurcation of cracks front. Further, it shows also that small pieces of the steel matrix could be delaminated inside the material. The second image, figure 5-b, indicates that cracks are active as they could delaminate the crack edges leading to close some cracks patterns.

Additional information can draw from figure 5-a about the non-metallic inclusions that seem to be present along the crack path. This is also reported in several rail research works [13] [14]. The missing link to understanding the exclusive spread of the spalling defect could be the overcharging of the inclusion neighbor in the head-hardened rail rather than the standard one. This is would be further considered in the following section.

Figure 5. Scanning electron microscopy observations of subsurface cracks of figures 4-a and c. a- Example of a crack cluster, b-Plastic deformation of the crack pattern edges.

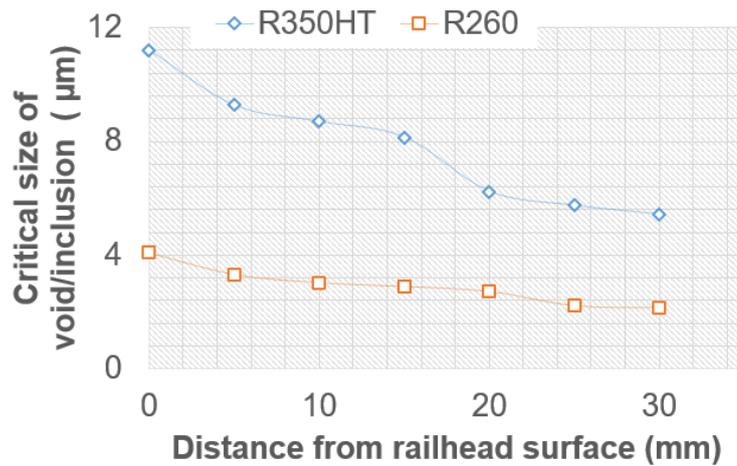
Figure 6. Comparison of subsurface cracking susceptibility between R260 and R350HT for an endurance shear limit of 350MPa.

Assuming that rail steels have comparable shear fatigue endurance of $\sigma_e = 350\text{MPa}$, figure 6 compares the evolution of inclusion size leading to crack initiation along the transversal profile of the rail head based on hardness reported in figure 3. It shows clearly that the R350HT is more susceptible to subsurface cracks. It is important to indicate that these results overestimate the critical size as no calculation has been performed to evaluate the sub-surface shear stress. Meanwhile, the 350MPa is a realistic stress value achievable in rail loading [17]. Considering these results, future work would focus further on the study of the estimation of fatigue limits and the cracking mechanism in the early stage of rail.
