Proceedings of the Sixth International Conference on
Railway Technology: Research, Development and Maintenance
Edited by: J. Pombo
Civil-Comp Conferences, Volume 7, Paper 11.1
Civil-Comp Press, Edinburgh, United Kingdom, 2024
ISSN: 2753-3239, doi: 10.4203/ccc.7.11.1
©Civil-Comp Ltd, Edinburgh, UK, 2024

A Study for the Installation of a Door Catch Detection Device using a Laser Sensor

**Research and Development Center of JR East Group
East Japan Railway Company
Tokyo, Japan**

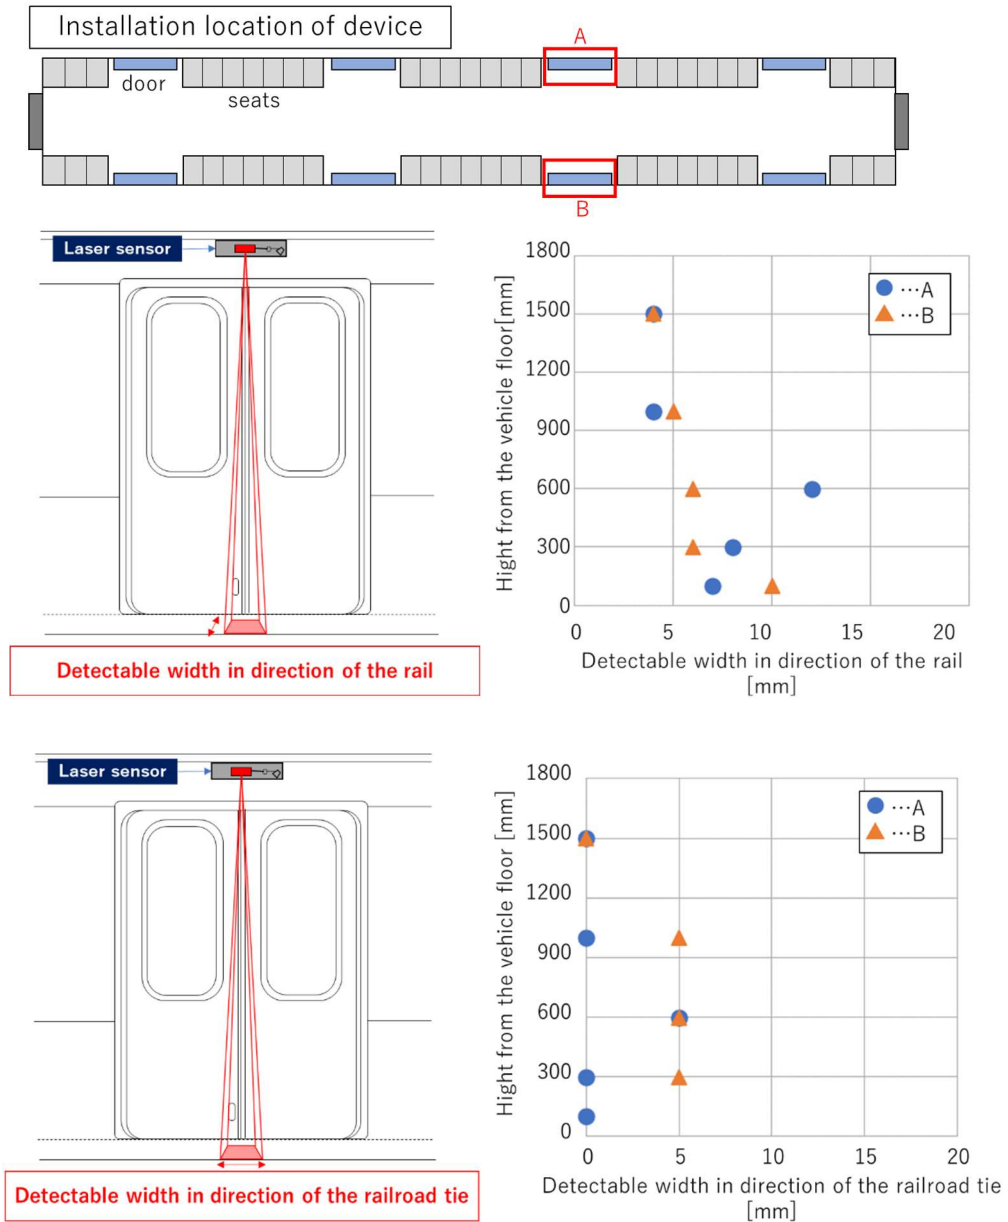
Figure 3: Results of detectable width

Here, we verified the “width” as the detectable range from the center position of the vehicle door. The detectable widths were verified for six heights (100, 300, 600, 1000, 1200, 1500 mm from the vehicle floor). We measured the detectable width by moving a board in the direction of the rail, which is the direction of the train is moving, and in the direction of the railroad tie, which is perpendicular to the rail. To check for variations due to the installation conditions of the laser sensor, we examined the width at two vehicle doors (door A and B in Figure 3).

Figure 3 shows the results. The detectable widths in the rail direction were less than 5 mm at a floor height of 1000 mm or higher, which is close to the laser sensor, while

the widths increased to about 12 mm at a floor height of 600 mm or lower. This is thought to be since the laser light projection range increases as it moves away from the laser sensor. On the other hand, the detectable widths in the direction of the railroad tie were found to be 0 to 5 mm regardless of the floor height, indicating that there is not much spread.

- 1) As a basic characteristic, it was confirmed that the laser sensor can detect door catching condition of objects up to 11 mm in thickness. The detectable width in the rail direction increased as it moved away from installation position of the laser sensor. On the other hand, in the direction of the railroad tie, there was no spread in the detectable width regardless of the distance from installation position of the laser sensor. Based on the results of the basic characteristic, the projection position of the laser light was examined.

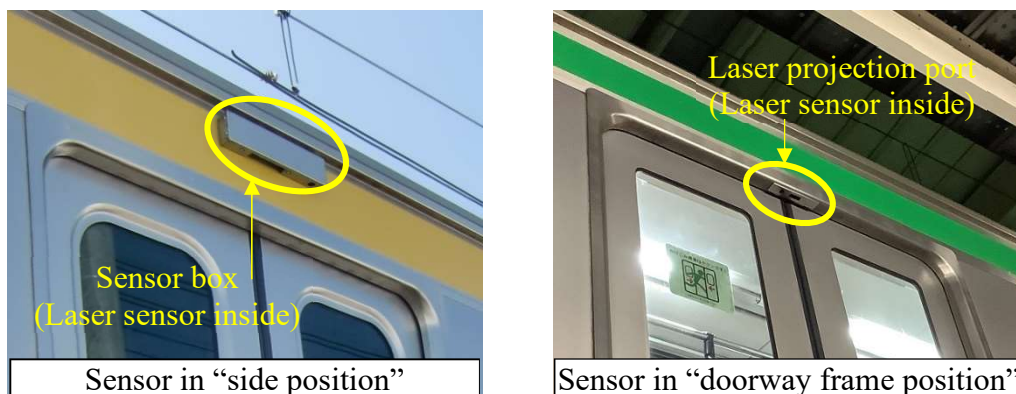
Figure 4: The installation position of laser sensor

Figure 4 depicts the installation position of laser sensors. Left side of Figure 4 shows the installation position of “side position”, which is the position of the laser sensor up to the previous section. In the case of the “side position” installation, the dimensions of the laser sensor itself are less restricted because it is installed on the side of the vehicle body. However, it was necessary to install a new sensor box to store the laser sensor and drill a hole in the side of the vehicle body to install the electric cable. There were also restrictions on maintenance work, such as the need to set up scaffolding outside the vehicle when adjusting the projection position or replacing the laser sensor in the event of a malfunction.

To solve the above issues, we considered installing the laser sensor at the position shown on the right side of Figure 4 (hereinafter, referred to as “doorway frame position”). In this installation method, the laser sensor is installed inside the vehicle

door header, and a laser light projection port is provided on the vehicle door entrance frame. Although there were restrictions on the dimensions of the laser sensor body due to the existing devices installed inside the door header, the selection of a compact sensor made it possible to install the sensor. The installation position of “doorway frame position” also made it possible to adjust the projection position of the laser sensor and replace the laser sensor from inside the vehicle without the need for scaffolding, thus eliminating the restrictions on maintenance work that existed when the laser sensor was installed in “side position”. As in the “side position” installation, the laser light was set to project into the space between the vehicle body and the platform in the “doorway frame position” installation.

- 3) To solve the problem of installing the laser sensor at “side position”, which requires the setting of a sensor box and wire holes, we consider installing at “doorway frame position”. Because a compact sensor made it possible to install the sensor inside the door header, and there was no significant difference in detection performance between the “side position” and “doorway frame position” installation, the laser sensor was installed on the “doorway frame position”. This allows adjustment of projection positions of laser light from inside the vehicle, thereby reducing the burden of maintenance work.

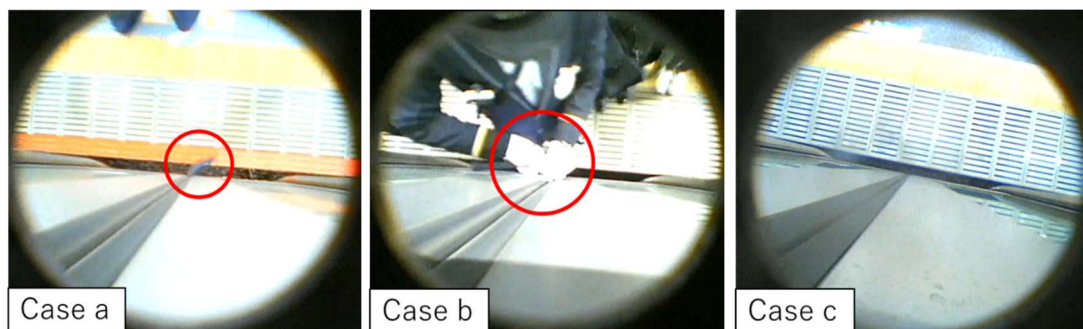
Figure 5: Example of detection records

- a. Partially caught in clothing or bag (Figure 5 a)
- b. Contact from outside of vehicle (Figure 5 b)
- c. No object (Figure 5 c)

Case “a” was detected when a passenger in the train was standing near the door due to crowding, etc., and his/her clothes or bag was caught in the door. The detection by the object was confirmed to be normal. When the caught object was pulled inside the train, the detection stopped because there was nothing left to reflect the laser light.

Case “b” was detected when a station attendant checked whether the train door was completely closed from outside the train on the station platform, and his/her hand got into the detection range. In this case, too, the detection by object was confirmed to be normal.

For case “c”, no object reflecting the laser light could be identified, although the detection record was confirmed. This is assumed to be due to the detecting the vehicle body as an object caught in the door due to misalignment of the projection position of laser light or detecting raindrops or dust adhering to the laser projection port. Since these detection case affects transport stability, the projection position of the laser light, its adjustment method, and cleaning of the laser light projection port should be considered.

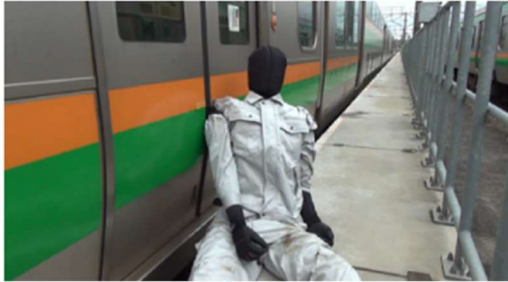
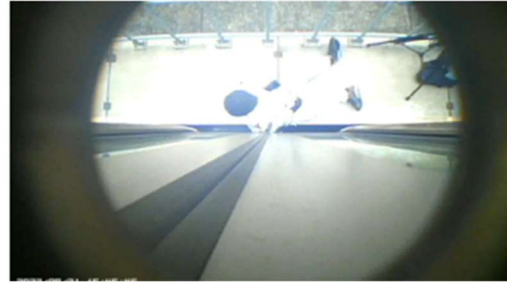
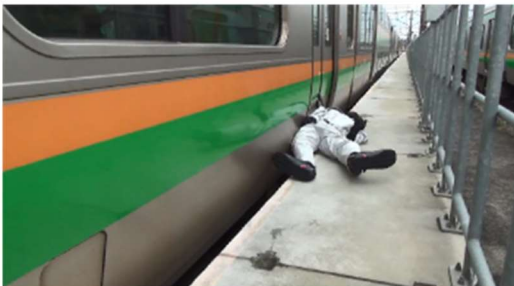
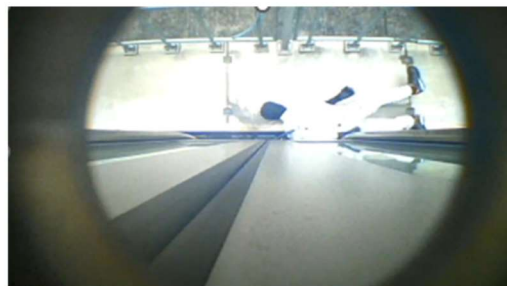
Figure 6: Vehicle start-up test with the bag wedged in the door

Figure 6 and Figure 7 show the test when the bag and the strap were wedged in the door, respectively, and Table 2 shows the results of each object.

In the case where the bag was wedged in the door, the doll and the bag were dragged along with it when the train moved. On the other hand, in the case where the strap or the clothing were wedged in the door, both escaped from the door shortly after the train moved and were not dragged.

The bag was detected when it was wedged in the door. However, after the train moved, it could not be detected in some cases. This is because when the train moved, the objects and the doll were dragged and thus moved relative to the door from their before-start up positions. Therefore, it is assumed that they had moved out of the detection range of laser sensor.

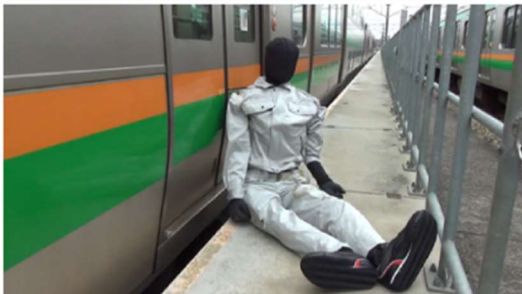
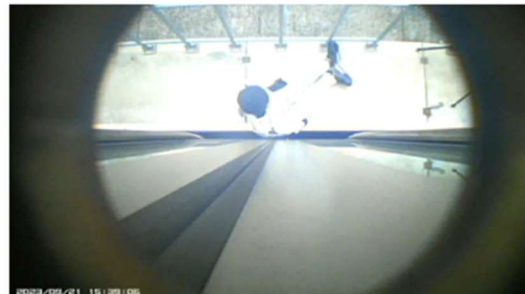
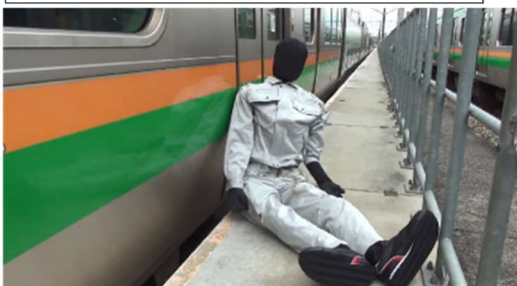
Figure 7: Vehicle start-up test with the strap wedged in the door

Regarding detection performance, the detection device could not detect the door catching condition of the strap. This is assumed to be due to the presence of the undetectable range of laser sensor between the vehicle door and the laser light. It is considered that the strap was in this range and therefore could not be detected.
