Proceedings of the Sixth International Conference on  
Railway Technology: Research, Development and Maintenance  
Edited by: J. Pombo  
Civil-Comp Conferences, Volume 7, Paper 8.15  
Civil-Comp Press, Edinburgh, United Kingdom, 2024  
ISSN: 2753-3239, doi: 10.4203/ccc.7.8.15  
©Civil-Comp Ltd, Edinburgh, UK, 2024

## **Demonstration of smart autonomous AI ultrasonic inspections to TRL 7**

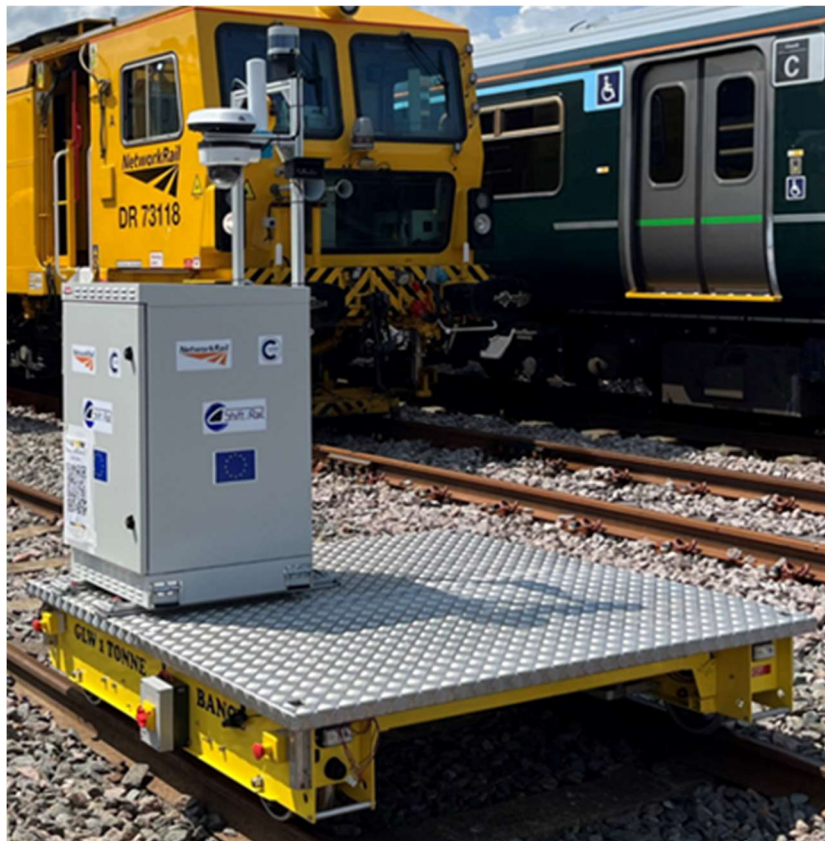
Figure 1 Autonomous Rail Trolley, equipped with LiDAR, GPS, Encoder and Camera

The new autonomous rail vehicle used was built upon a manual-controlled motorised trolley from BANCE®. It was procured and upgraded to become an autonomous robot platform capable of self-navigation and obstacle avoidance functionality using a more secure ROS 2 framework [10], see Figure 1. This vehicle is lightweight, battery-powered, and capable of carrying a payload of up to 830 kg while reaching speeds of up to 8 km/h. In order to implement autonomous a more straightforward driving capability, seven speed levels were pre-defined covering the vehicle speed range.

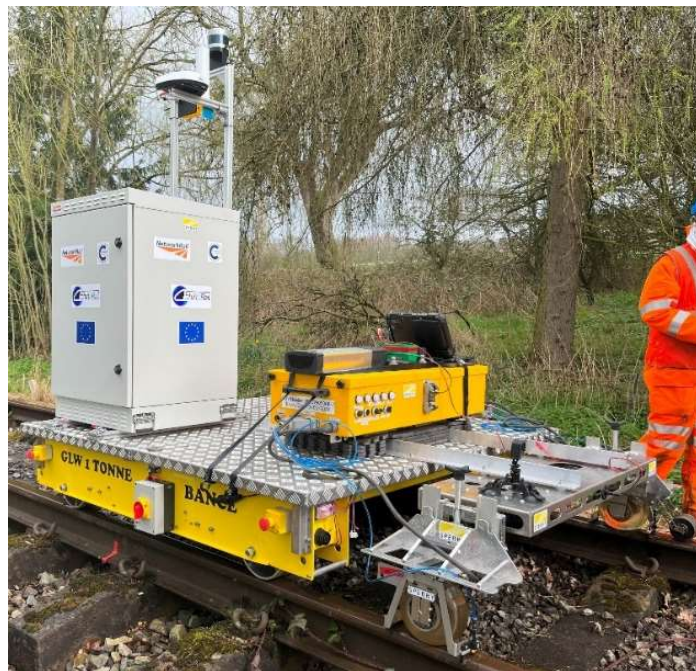
Fig.2 Integrated autonomous ultrasonic rail inspection system prototype.

The inspection system and trolley platform are joined by simply using an aluminium fixture. The computer, batteries and water tank were positioned at the vehicle front platform and secured in place with foam energy absorbers to suppress vibrations. Since the inspection system does not inherently possess an autonomous inspection capability, the researchers established a serial port communication interface protocol between the vehicle and UT system to enable control of the inspection procedure and start and stop functions. Three string commands were employed. Initially, UT system transmitted the 'CTR\_RD' command to the vehicle to indicate that inspection kit is on standby. Subsequently, the vehicle sends the 'CTR\_ST' command to the UT system to initiate the inspection process, while the 'CTR\_SP' command is used to terminate data collection. The integrated prototype is shown in Figure 2.

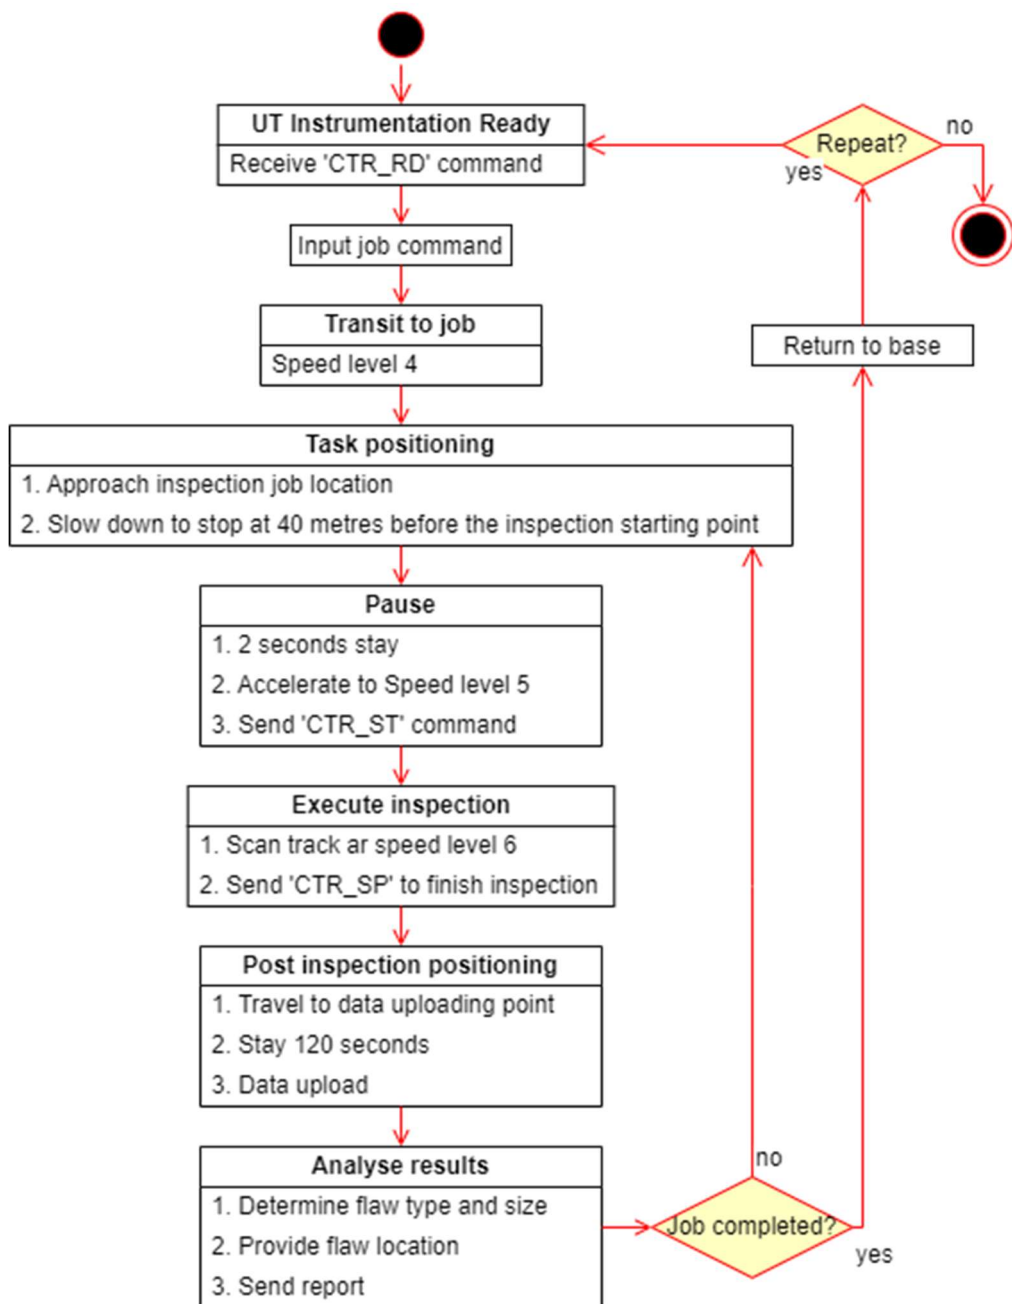
Fig.4 Flow chart of the sequence in the demonstration

Figure 4 details the corresponding sequence flow chart. The UT system issued a 'CTR\_RD' command to the vehicle when the prototype was positioned at the base and remained in a standby state. The operator then initiated the sequence command to commence the procedures. During Stage 1, the approaching phase, the vehicle proceeded from the base to the yellow cone position at speed level 4 until it reached the yellow cone, where it stopped momentarily before resuming acceleration to reach speed level 6 prior to the red cone. At this point, the vehicle transmitted the "CTR\_ST" command to the UT system to initiate data collection at the red cone location. The prototype then continued to propel the probes at speed level 6 until it reached the blue cone and issued the "CTR\_SP" command to cease inspection work. Subsequently, the vehicle reduced its speed to level 4, arriving at the data uploading point, which marks the endpoint of the test. The prototype remained in this location for a duration of 2 minutes to enable the uploading of the acquired data. Finally, the prototype navigated to the base at a speed level 4 and remained in standby mode, awaiting further instructions.
