Proceedings of the Fourteenth International Conference on
Computational Structures Technology
Edited by B.H.V. Topping and J. Kruis
Civil-Comp Conferences, Volume 3, Paper 9.1
Civil-Comp Press, Edinburgh, United Kingdom, 2022, doi: 10.4203/ccc.3.9.1
©Civil-Comp Ltd, Edinburgh, UK, 2022

Forgotten and suffering structures – detailed inspection and finite element analysis of two railroad masonry arches in Poland

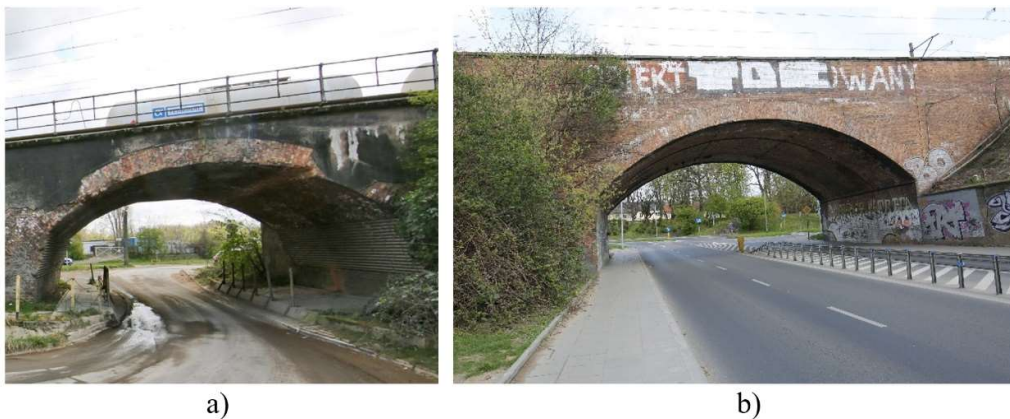
This paper is focused on the aspects that have been discussed above. Structural response and load capacity estimation problems of two existing masonry arch railroad bridges are described. Both were constructed at the turn of the XIX and XX centuries and are located in Szczecin (Poland) over Fabryczna and Wilcza Streets, as shown in Figure 1. They are currently in poor condition and were carrying traffic until 2017.

Figure 1: The analysed bridges: a) over the Fabryczna street, b) over the Wilcza street.

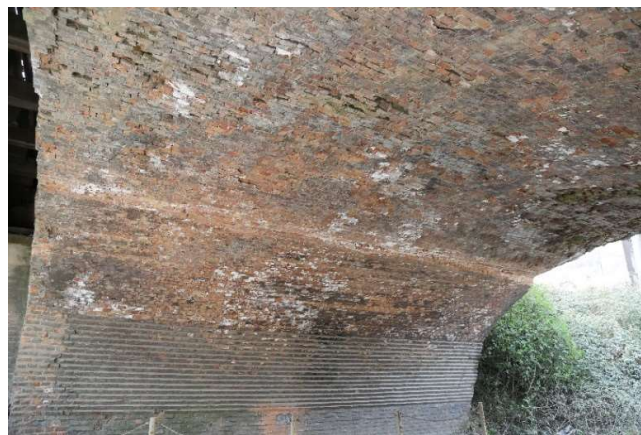
Archival technical documentation was analysed and detailed inspection was done at first for the bridges. Some drawings depicting the geometrical properties of the studied arches are shown in Figure 2 to Figure 5. The bridge over the Wilcza street is not a typical one. The middle arch with constant thickness was built in 1896. Then it was rebuilt in 1940 (spandrel walls were partially disassembled) and two adjacent external arches with varying thickness were constructed. The three arches are separated with expansion joints. Both bridges are in poor condition (see Figure 6 and Figure 7 for the intrados damage) and require immediate repair works.

Figure 6: Intrados damage of Fabryczna Street bridge.

This state of stress could have contributed to the deterioration of the Fabryczna street masonry arch. The estimations of the bridge response are in accordance with the inspected damage, observed all over the intrados surface (refer to Figure 6). The bridge has not collapsed because the real masonry strengths are higher than the recommended ones (see Loo [11] and Ng et al [13], compare with [6]). What is more, the structure is located close to the railway station and the train speeds have been possibly low in this area, which resulted in minimalization of dynamic effects. Formally, according to the code [6] the bridge is not able to carry loads of C3 class.

Both bridges need structural modification, if the local administration wants to reopen them to traffic. These specific bridges definitely deserve restoration works, as they are part of the engineering history, which beautiful examples should be preserved.

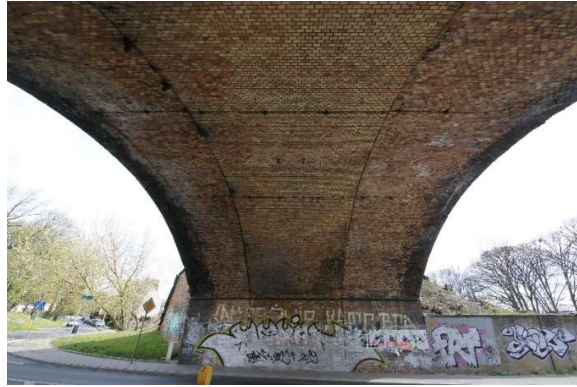
Figure 7: Intrados damage of Wilcza Street bridge.

Similar conclusion can be drawn for the Wilcza streets arches (Figure12). However, in this case only circumferential stresses are important, while the longitudinal ones are rather small. The highest circumferential stresses are mainly located close to the external sides of the external arch barrels, while the state of stress in the middle barrel is more favourable. This coincides with the inspected bridge condition.
