Proceedings of the Fifth International Conference on  
Railway Technology:  
Research, Development and Maintenance  
Edited by J. Pombo  
Civil-Comp Conferences, Volume 1, Paper 27.7  
Civil-Comp Press, Edinburgh, United Kingdom, 2022, doi: 10.4203/ccc.1.27.7  
©Civil-Comp Ltd, Edinburgh, UK, 2022

## **Data Acquisition for Abnormality Detection using an Experimental Bogie on Test Track**

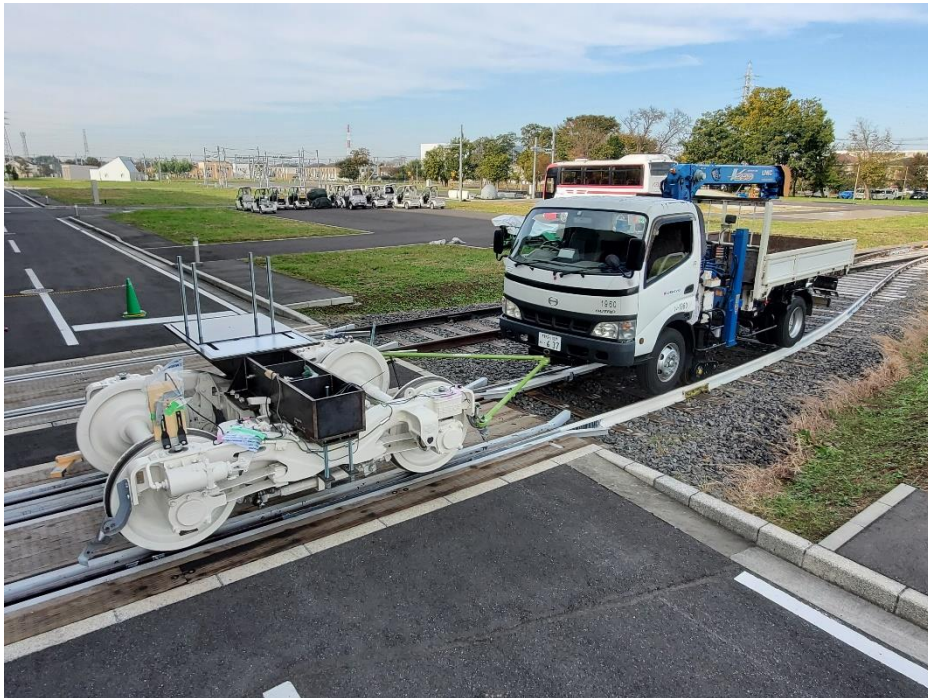
Figure 1: The experimental train under normal conditions.

## 2 Methods

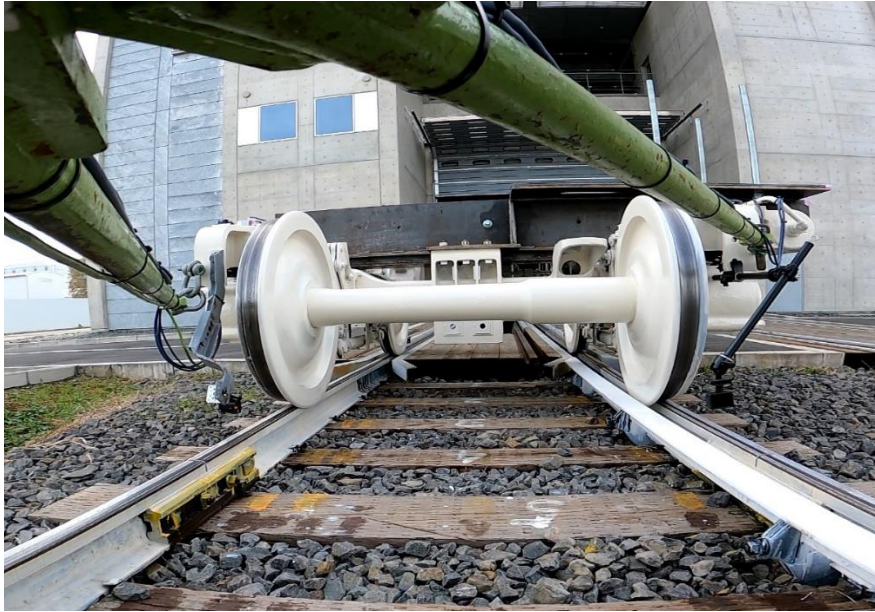
Figure 2: The experimental train under normal conditions can normally pass through the R30 curve section.

The experimental train under normal conditions can normally pass through the R30 curve section (figure 2). On the other hand, the experimental train which the balance of the wheel load was significantly changed, cannot pass through the R30 curve section. That is, a wheel climb occurred and hit with a derailment prevention guard (figure 3). Figure 4 shows an example data including the wheel climb.

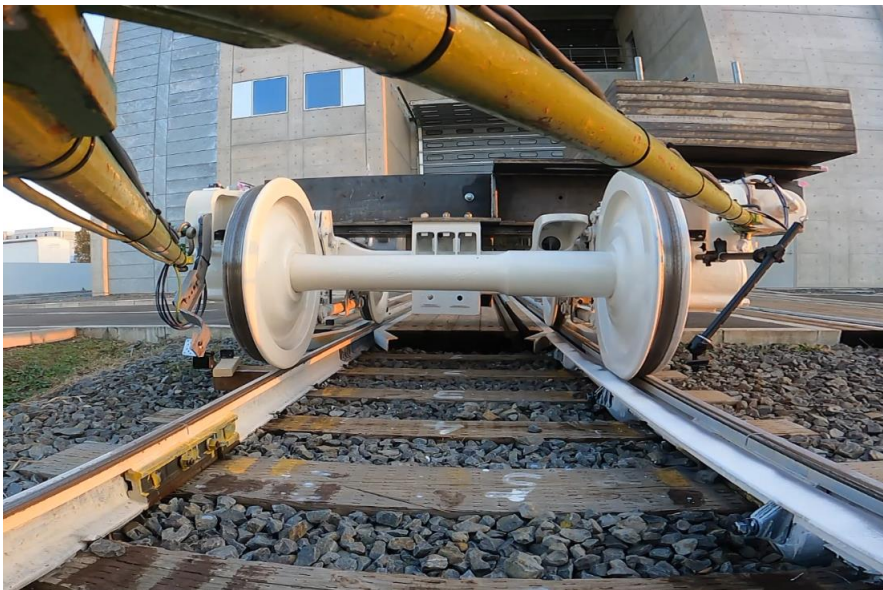
Figure 3: The experimental train under wheel load unbalance conditions cannot pass through the R30 curve section (wheel climb).
