Experimental Investigation of the Track Dynamic Performance for a Downslope Small-Radius Curve in a Metro

X. Liu, H. Jiang, Y. Chen and M. Gao

China Academy of Railway Sciences (Shenzhen) Research and Design Institute Co. Ltd., China Academy of Railway Sciences Corporation Limited
Beijing, China

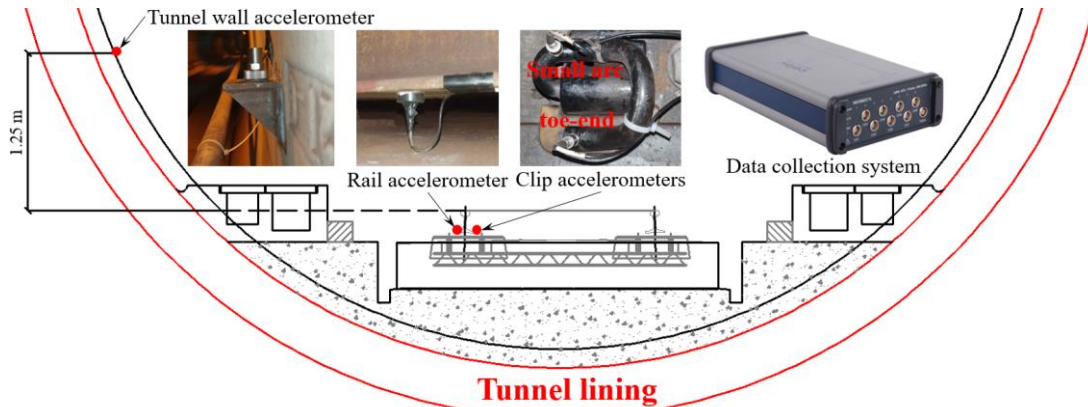
Figure 2: Setup of track vibration test points.

The negative impact of the rail corrugation is quite serious. Sudden fracture of clips has been frequently reported in this section. The fracture point is mainly in the small arc (Figure 2). In this study, the vibrations of a clip (near the rail vibration test point) in both the toe-end and the small arc are measured. The clip measurement results of the left line before grinding are presented in Figure 10 and Figure 11.
