Proceedings of the Sixth International Conference on Railway Technology: Research, Development and Maintenance Edited by: J. Pombo Civil-Comp Conferences, Volume 7, Paper 7.10 Civil-Comp Press, Edinburgh, United Kingdom, 2024 ISSN: 2753-3239, doi: 10.4203/ccc.7.7.10 ©Civil-Comp Ltd, Edinburgh, UK, 2024

On Wayside Detector Measurement of Wheel-Rail Impact Loads Induced by Wheel Flats - Data Analysis, Alarm Levels and Regulations

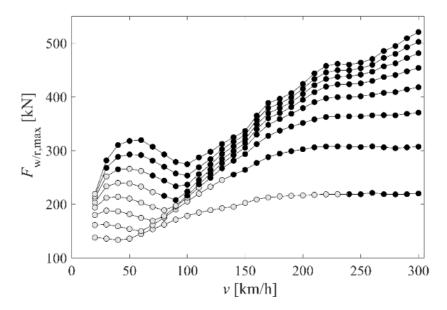
Figure 1: Simulated peak loads (including static wheel load 118 kN) due to a rounded wheel flat with length $l = 1.76 \cdot l_0$. The lines (from lower to upper) correspond to flat depths d = [0.25, 0.50, 0.75, 1.00, 1.25, 1.50, 1.75, 2.00] mm. Each circle illustrates the maximum of the impact loads from eight simulations with different initial angular positions of the wheel within one sleeper bay. Black circles indicate that loss of contact occurs for at least one of these eight simulations. From [11].

Field tests of dynamic vehicle–track interaction involving trains with different types of wheel tread irregularities have been reported in several studies, see [4–10]. For a given wheel flat, these measurements have indicated a local maximum in vertical wheel–rail contact force (impact load) in the train speed interval 30 - 60 km/h. It has also been reported that the speed of this local maximum was increased with increasing axle load [7]. For comparison, the simulated influence of train speed and depth of a wheel flat on the generated impact load is illustrated in Figure 1 [11]. With increasing flat depth *d*, it is shown that the magnitude of the impact load increases and momentary loss of wheel–rail contact occurs at a lower train speed. In the figure, it is observed that the speed dependence is essentially similar for different depths, but the local maximum and minimum of each curve are more pronounced for larger depths and are also shifted to higher speeds.

- For locomotives, the 'high' alarm level is 425 kN.
- If a locomotive wheel generates a peak load exceeding 350 kN and the ambient air temperature is below -10 C°, train speeds in the interval 15 45 km/h should be avoided [16], cf. the local force maximum in Figure 1.

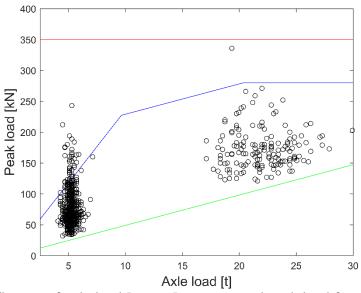
Figure 3: Influence of axle load [tonnes] on measured peak load for all 823 analysed detector passages. The red line is the 'high' alarm at 350 kN. The blue line indicates warning levels set by Trafikverket in terms of ratio (axle loads up to 10 tonnes), dynamic load (axle loads in the interval 10 – 20 tonnes) and peak load. The green line illustrates the relation between mean load and axle load. From [17].

- 'Warning' levels are set at 280 kN (peak load), 180 kN (dynamic load) and 4.8 (ratio) independent of vehicle type.
- If the measured peak load, dynamic load or ratio exceeds a 'warning' level (but not the peak load 350 kN), cf. Figure 3, the train may continue without regulations to its destination. From there it is not allowed to continue operating until the wheel has been rectified and approved by certified staff. This regulation holds unless it is found that the length of the wheel tread damage exceeds 60 mm.

All data from passages at train speeds below 40 km/h were filtered out since the RFID tag used for identifying wheelsets was not considered accurate for those speeds. Only the highest peak load per axle and detector passage was included in the analysis. The wagons in the analysis were either loaded or unloaded. The analysis of unloaded wagons consisted of wagons with axle loads in the interval 4.5 - 6 tonnes and speeds between 69 and 120 km/h. The number of detector passages with unloaded wagons was 645. The loaded wagons, on the other hand, had a range of axle loads between 17 and 25 tonnes and speeds in the interval 64 - 90 km/h. The number of detector passages for the loaded cases was 159. Figure 3 illustrates a summary of peak loads for all detector passages included in the analysis. The blue line indicates the warning levels issued by Trafikverket. It is observed that most warning alarms were set off for unloaded wagons in the form of ratio alarms for wagons with axle loads of around 5 tonnes.

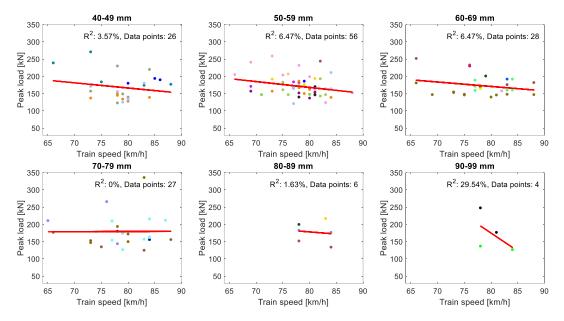
Figure 4: Influence of train speed on measured peak loads: different wheel flat length intervals, loaded wagons with axle loads 17 – 25 tonnes. From [17].

For different intervals of wheel flat length, and for loaded and unloaded wagons, Figures 4 and 5 present the influence of train speed on measured peak loads. A linear regression has been made in each subplot to indicate any possible trend in the data, but as the R^2 -value (coefficient of determination) is generally very low this could not be confirmed. In some of the subplots, the number of data points is very small. Nevertheless, based on these measurements, there seems to be no evident increase in peak load with increasing train speed for any of the wheel flat length intervals. Neither can a local maximum as in Figure 1 be observed. In each subplot, each colour represents one specific wheel flat. Thus, if the same colour is repeated several times, this means that the same wheel flat has passed several detectors. For the two wheels on an axle, the highest peak load was extracted from each detector passage. Thus, the same colour could potentially represent either the left or the right wheel on the same axle. As mentioned above, wheel flat lengths were measured in the workshop before the wheels were turned. Figures 6 and 7 show the same data, but in this case for different intervals of train speed. Although the scatter in data is again very significant, an expected trend indicating higher peak loads with increasing flat length can be distinguished in most subplots.

Figure 8 presents the cumulative distributions of peak load for the same data as in Figure 4. The red line indicates the 'high' alarm limit of 350 kN, while the orange dashed line is the warning level 280 kN set by Trafikverket. In summary, based on the 823 investigated detector passages with wheel flats of different lengths, there was no case of peak load exceeding 350 kN. This was surprising since several of the investigated cases involved wheel flats significantly longer than 60 mm.

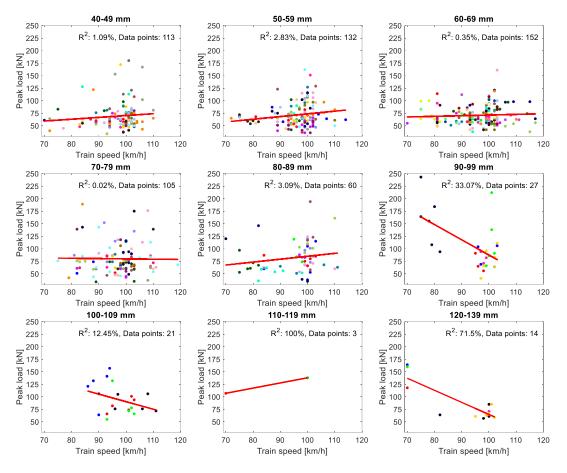
Figure 5: Influence of train speed on measured peak loads: different wheel flat length intervals, unloaded wagons with axle loads 4.5 – 6 tonnes. From [17].

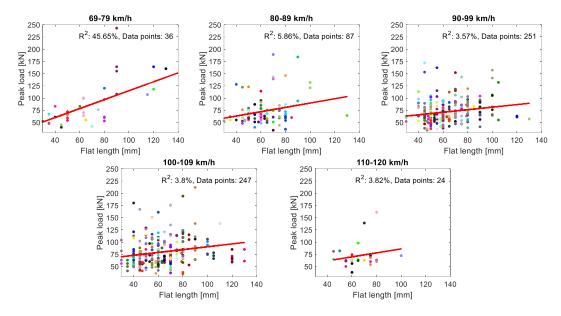
Figure 7: Influence of wheel flat length on measured peak loads: different train speed intervals, unloaded wagons with axle loads 4.5 - 6 tonnes. From [17].

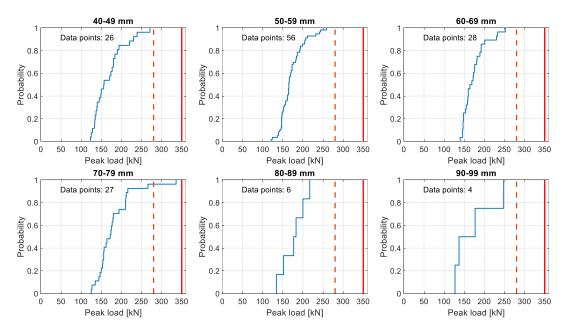
Figure 8: Cumulative distributions of peak load for different intervals of wheel flat length: loaded wagons with axle loads 17 – 25 tonnes. From [17].

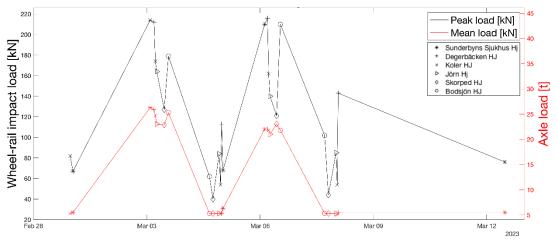
Figure 9: Peak loads and axle loads for one given wheel flat with length 75 mm measured in six WILDs along the route of *Stålpendeln*. From [17].

For a given 75 mm wheel flat, all registered peak loads and mean loads in six different WILDs along the route of Stålpendeln have been studied, see Figure 9. The presented data covers the period from when the flat had been generated until the wheelset was taken out of service for repair. Two journeys in loaded conditions and three journeys in tare conditions are considered. A large variation in measured loads between different detectors during a given journey is observed. Further, a clear pattern in how the detectors measured relative to each other is noted, see for example differences in data from the detectors at Degerbäcken and Skorped. This indicates that besides the

variation in speed and other influencing variables, the condition of the detectors might have affected the measured loads. The time since calibration, and measurement accuracy, may vary between individual detectors. In particular, it may be argued that the ability of the detectors to measure high-frequency impact loads is uncertain.

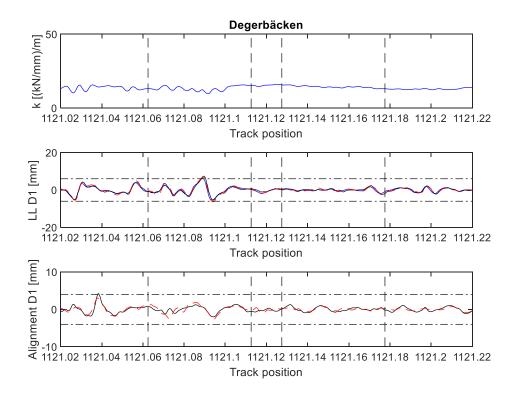
Figure 11: Foundation stiffness, longitudinal level (bandpass filtered 1 – 25 m) and alignment (1 – 25 m) measured over a distance of 200 m in the WILD at Degerbäcken. Blue curves were measured on 2022-06-07. Black (left rail) and red (right) curves were measured on 2023-05-31. The inner pair of vertical lines indicates detector area 1 (15 m), while the outer pair of vertical lines indicates detector area 2 (50 m on either side of detector area 1). Horizontal dash-dotted lines indicate suggested tolerances in terms of planned maintenance for tracks with maximum allowed speed up to 160 km/h.

In parallel, track foundation stiffness and track irregularities in the detectors along the route of *Stålpendeln* have been measured by track recording cars [18], see Figures 11 and 12. For the WILD at Degerbäcken, it was found that measured vertical track stiffness is relatively uniform and that the track geometry is within the proposed tolerance limits. On the other hand, it is observed that the WILD at Skorped has irregularities within the detector area both in terms of track stiffness and track geometry, which could affect the vehicle dynamics while passing through the detector. In summary, the calibration of the detectors, as well as the measured variations in track stiffness and track geometry at the detector sites might have contributed to the scatter in measured peak loads.

Detector data needs to be reliable with a robust and transparent procedure for calibration and post-processing of data. To this end, detectors need to be calibrated regularly. A calibration of mean (quasi-static) load can be employed based on passages of axles with known axle loads (typically a fleet of locomotives) at low speed. The calibration of the dynamic load is more cumbersome as it can be expected that the detector measurements are dependent on the frequency contents of the load, load magnitude, temperature, etc. The calibration should be based on the traffic on the line (axle load, speed, passenger/freight etc.). Further, as illustrated in Figures 11 and 12, irregularities in track geometry and track stiffness should be monitored and rectified.

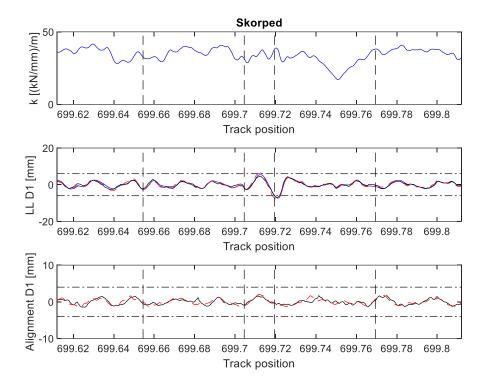
Figure 12: Foundation stiffness, longitudinal level (bandpass filtered 1 - 25 m) and alignment measured in the WILD at Skorped. Blue curves: 2022-10-05. Black and red curves: 2023-08-13.
